Gimp Testing Update

Heavy Photon Search SVT Meeting

Testing Overview

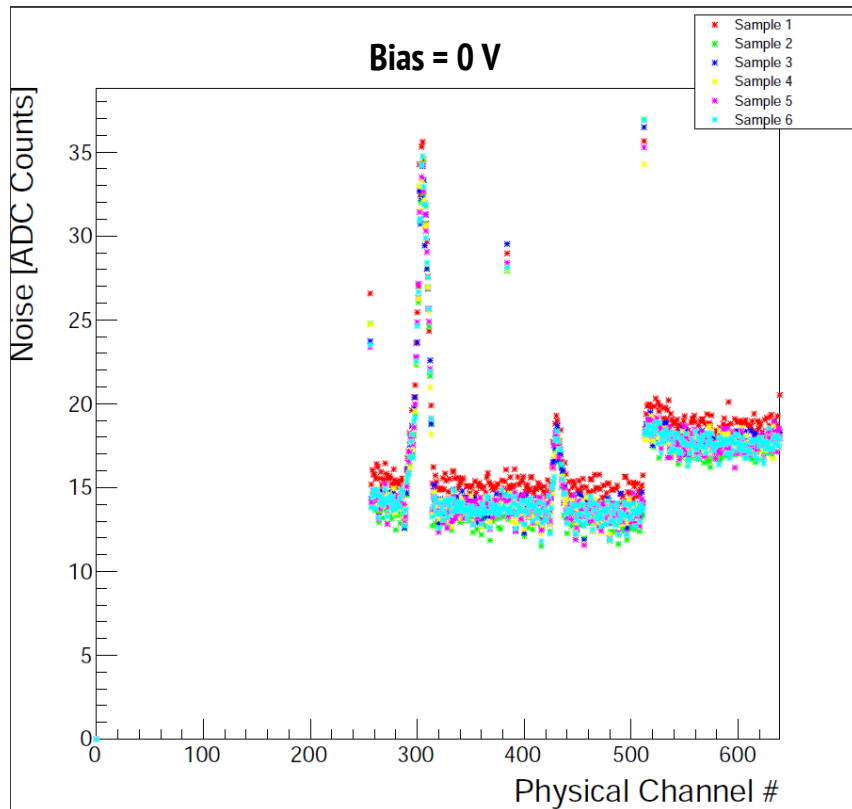
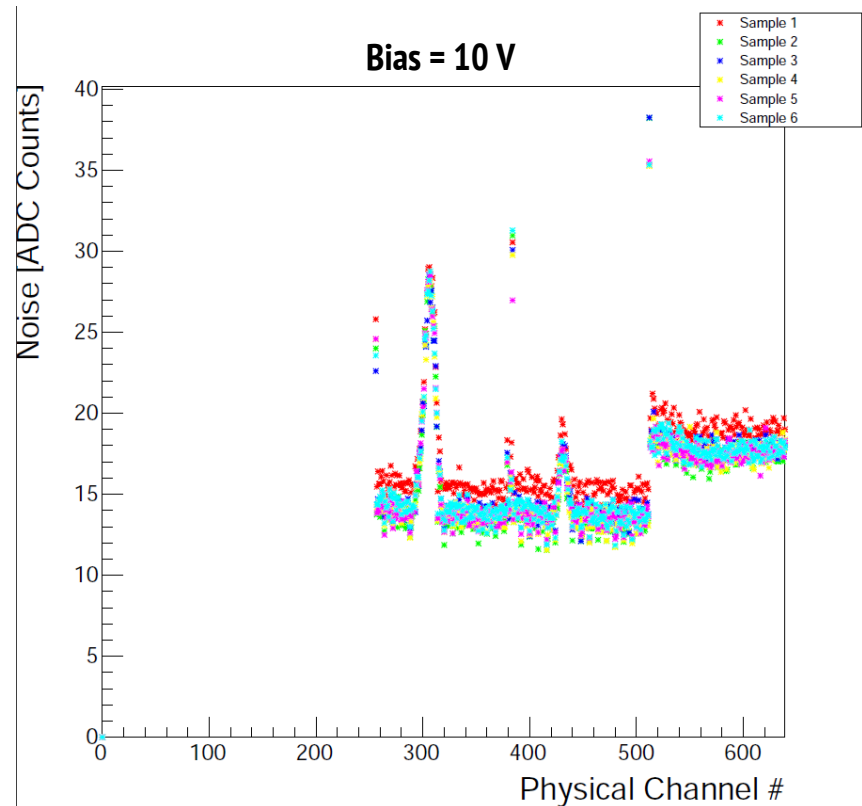
Run with sensor bias at 0 V and 10 V

- ❖ Noise for unbonded APV is as expected at ~20 ADC counts
- ❖ Noise for misbehaving APVs is ~15 ADC counts
 - Expected the noise of the APV with the pulled wirebonds to be similar to the unbonded APV
 - Expected large noise for bonded chip
- ❖ “Noise spikes” are present in the same region on both misbehaving chips

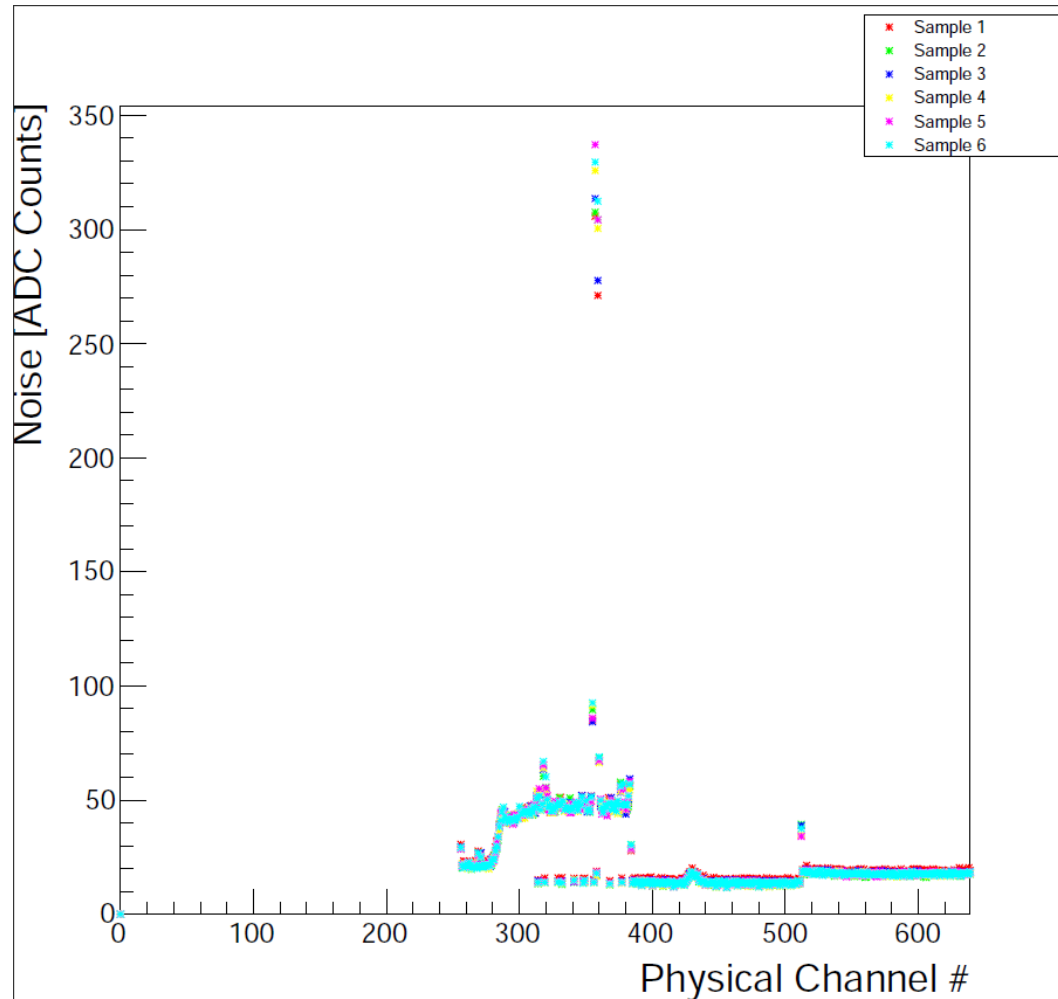
Run with sensor bias at 180 V

- ❖ Same noise pattern which was observed before is present on bonded chip

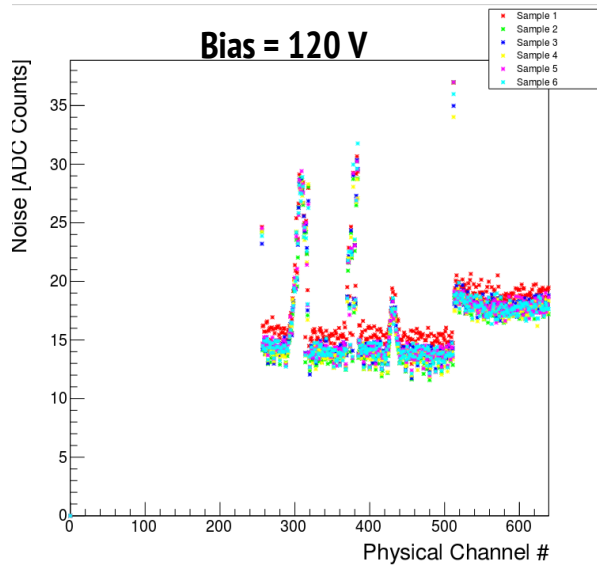
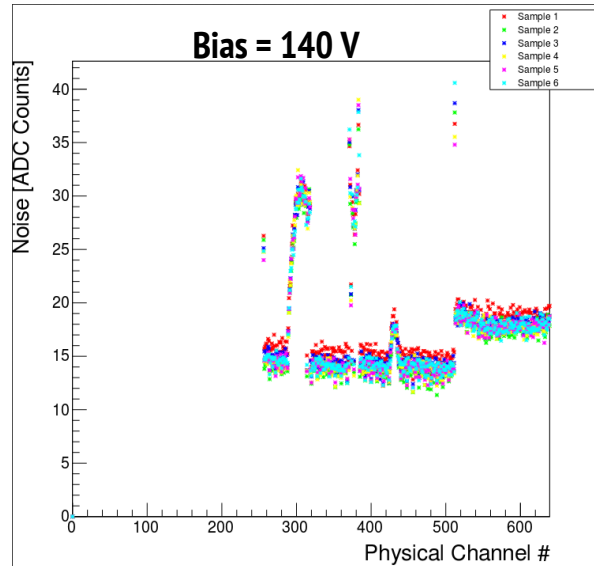
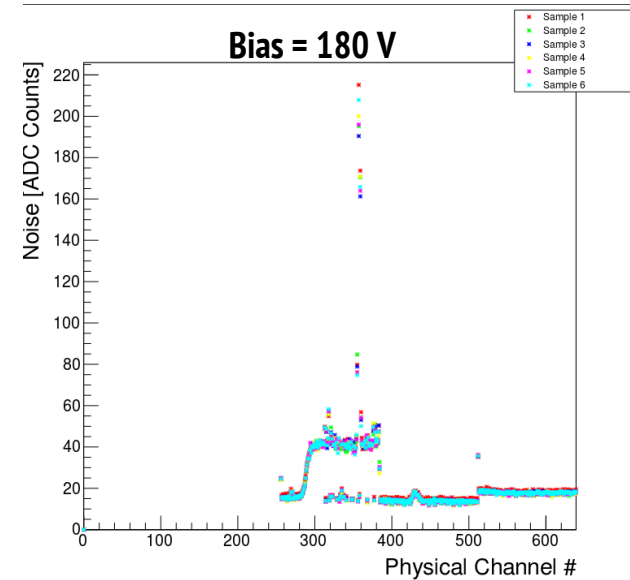
Run with sensor bias at 120 V, 140 V and 160 V

- ❖ Noise pattern is gone at 120 V and 140 V and present at bias voltages ≥ 160 V
 - Noise at 120 V looks like that observed at 0 V and 10 V
 - Additional noise spike has appeared at 120 V and 140 V

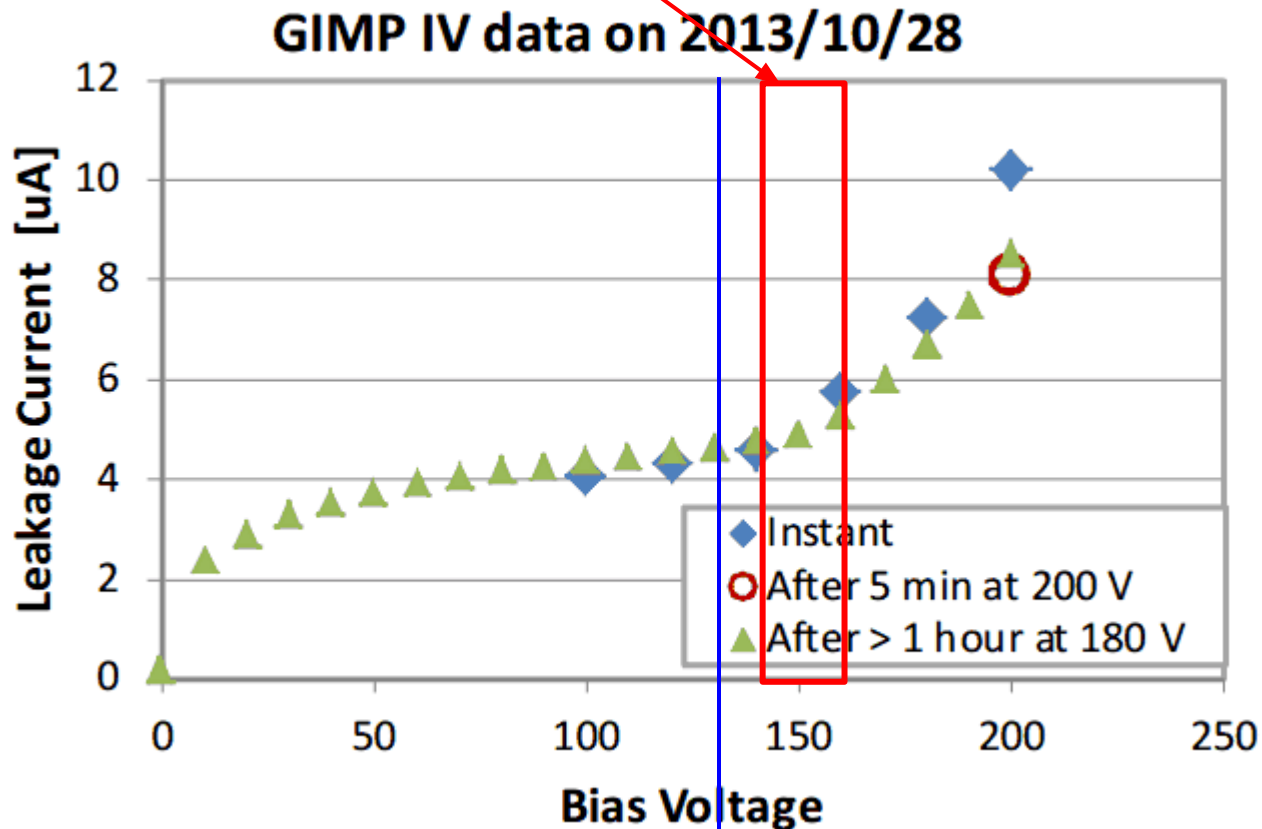
Leakage Current

- ❖ Bias region where noise pattern emerges seems to coincide with sudden increase in leakage current

Depletion Voltage at 132 V

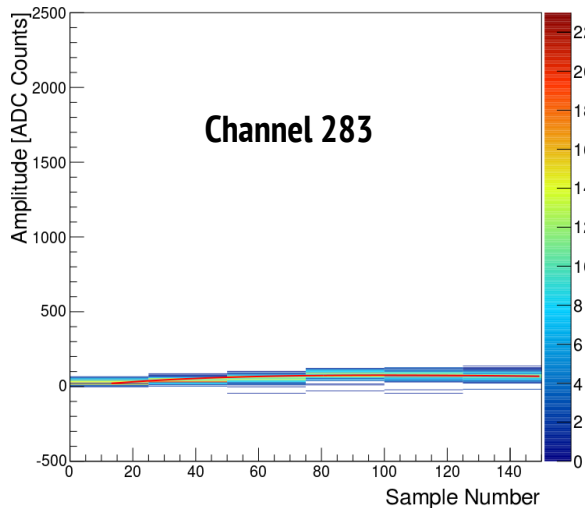
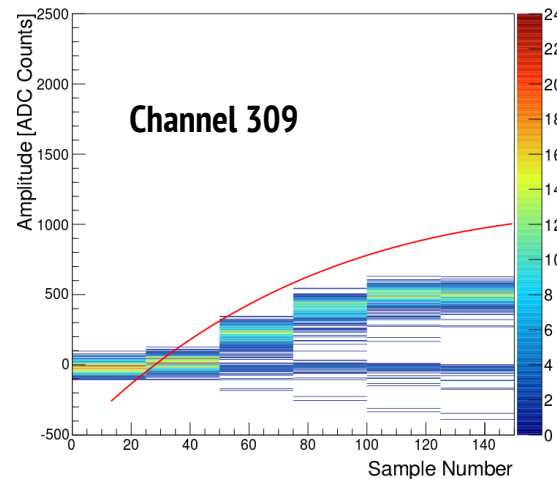
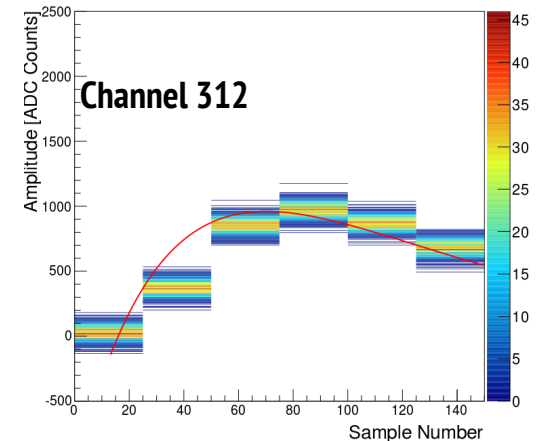
Calibration Response

- ❖ Calibration run taken with sensor biased to 180 V
- ❖ Calibration response of unbonded channels looks as expected
- ❖ Response of the bonded chip is either ~ 0 or is low (~ 500 ADC Counts)
 - Response of calibration group 0 starts out strange but improves across the chip

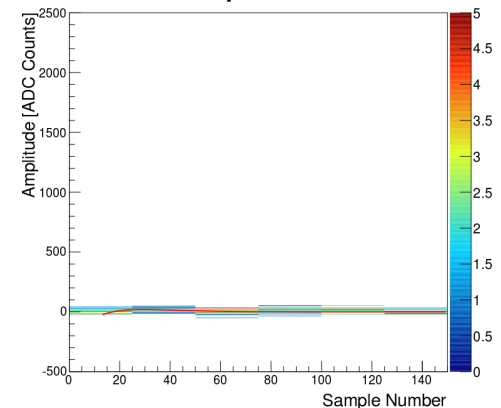
- ❖ The channels of the APV with pulled wirebonds do not respond to a calibration pulse
 - Seems to be indicating that the chips are dead
 - Trying to understand the noise pattern is irrelevant at this point
 - Sensor may or may not be damaged; It's hard to tell without IV curves taken before the test
