# EPIX10KA2M Charge injection fit issue 2021-05-20

## Issue with non-uniform pulser intensity increment between events

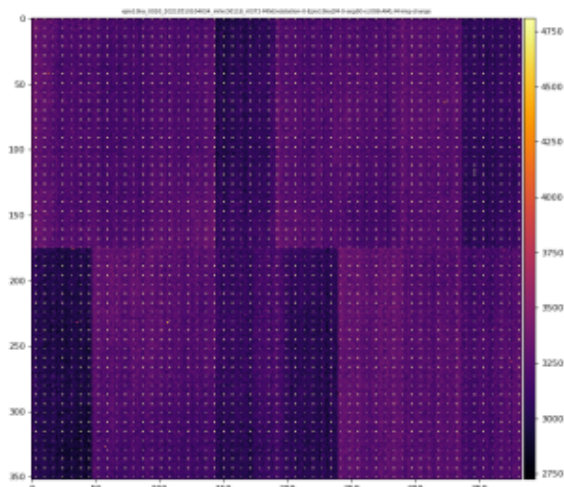
epix10ka\_0026\_20210510164634\_mfxc00118\_r0372-MfxEndstation-0-Epix10ka2M-0-seg00-cc008-AML-M-img-charge.png

Issue was seen earlier, recently reported by Philip due to poor fit Chi2.

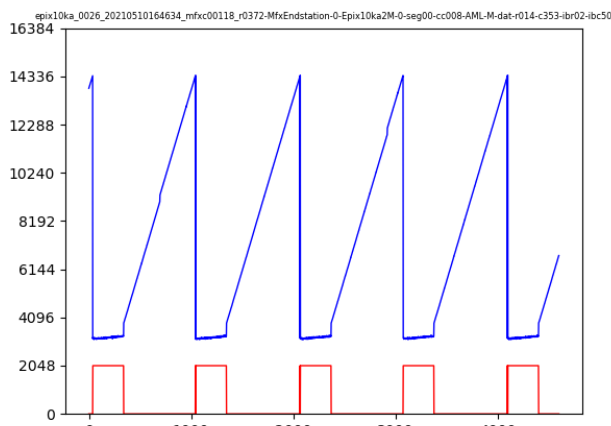
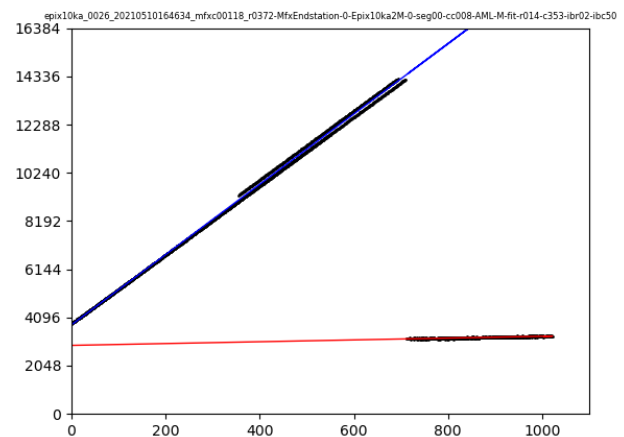
- 694-695
- 2919-2920

- nevt - counter for any det.raw()
- nrec - counter for det.raw() is not None
- fid = evt.get(EventId).fiducials() **normal increment between events is 3**

The gap in time between events happens twice in this cc.

Hi, If the pgpcard is seeing event code 40s on it's timing fiber it will still trigger acquisitions of the camera and increment the pulser. The running state of the daq has no affect on this. Generally the best we can do (which should be fine) is to assume pulser increments every three fiducials

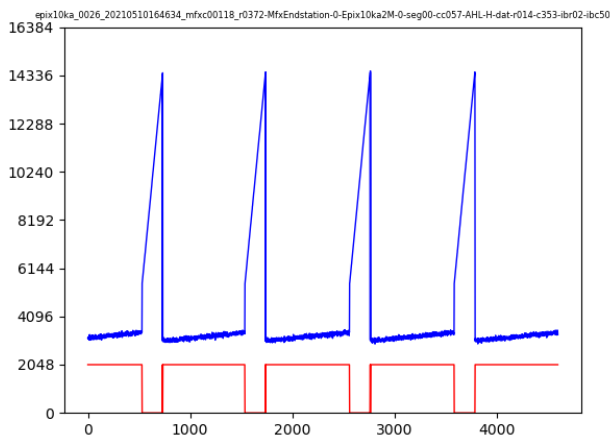
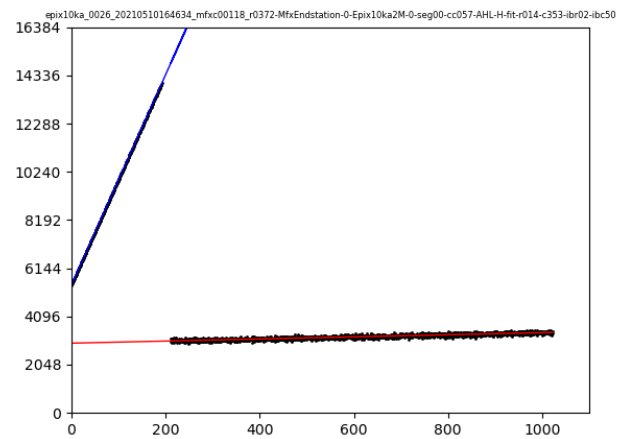
Normal behavior
