Link Robustness Issues

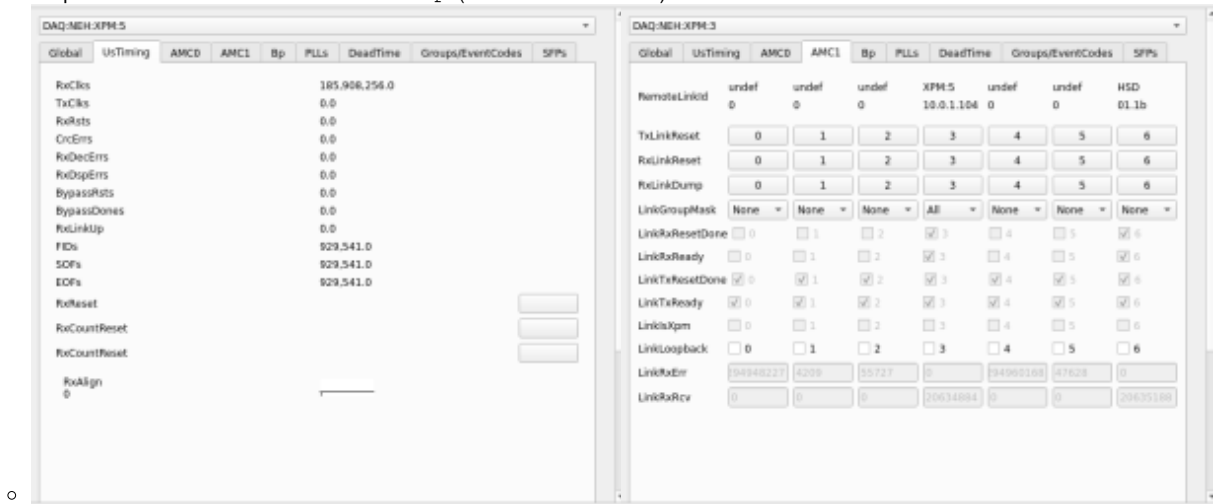
- XPM Link issues 2024/04/10-2024/04/11:
 - Around 14:00-14:10 on 2024/04/10, RIX Grafana page shows there were fairly global XPM issues (measured by XPM RxDspErrs rates)
 - XPM5 link (XPM3-5) goes down around 14:07 on 2024/04/10
 - Other XPMs recover but 5 does not, and the link stays down.
 - xpmmpva shows XPM5 looks mostly healthy except for the RxLinkUp
 - Required TxLinkReset to restore RxLinkUp (on 2024/04/11 ~09:15).

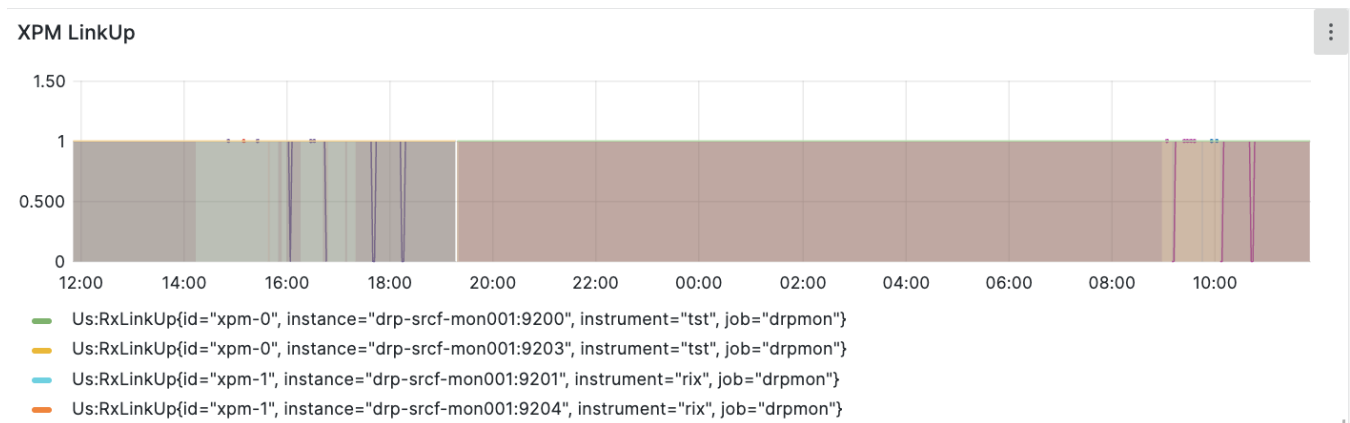
Observation Of Front-Panel XPM Link Glitch With Version 3.5.4

XPM11 glitches between 4pm and after 6pm and also around 10:10 am the next day

Perhaps fixed by Matt in later firmware version?
