# Link Robustness Issues

## 1. Summary Of Testing

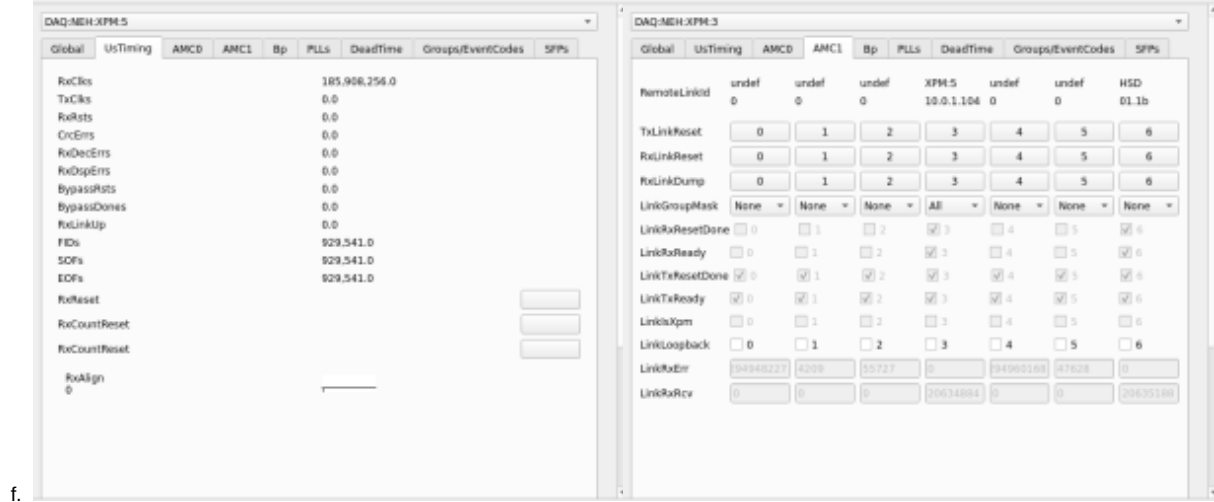
2. XPM Link issues 2024/04/10-2024/04/11:
  - a. Around 14:00-14:10 on 2024/04/10, RIX Grafana page shows there were fairly global XPM issues (measured by XPM RxDspErrs rates)
  - b. XPM5 link (XPM3-5) goes down around 14:07 on 2024/04/10
  - c. Other XPMs recover but 5 does not, and the link stays down.
  - d. xmpvva shows XPM5 looks mostly healthy except for the RxLinkUp
  - e. Required TxLinkReset to restore RxLinkUp (on 2024/04/11 ~09:15).

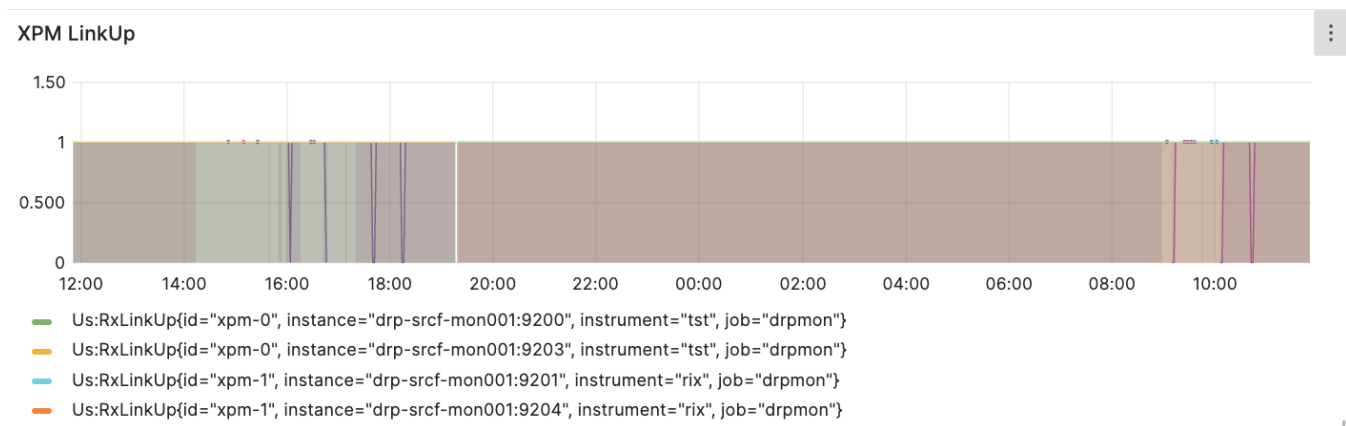
Perhaps fixed by Matt in later firmware version?

XPM11 glitches between 4pm and after 6pm and also around 10:10 am the next day
