# Link Robustness Issues

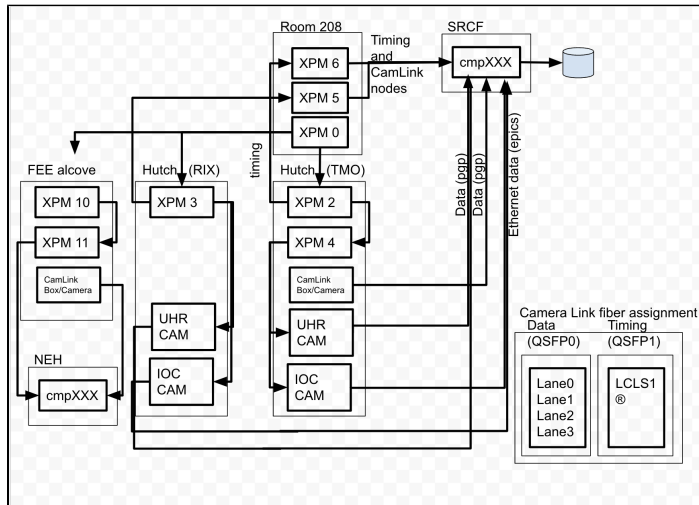
xpm10 and 11 connections

action	result	remedy	result
Remove XPM10 fiber timing in the back while DAQ running	*** XpmDetector: timing link ID is fffffff = 4294967295^M Timing 1 shutdown	TxlinkReset of cmp015 in XPM11	DAQ recovers
Repeat XPM10 fiber timing removal removal	DAQ cannot disable	---	DAQ recovers by itself at restart
Repeat XPM10 fiber timing removal removal	---	---	no issue
Repeat XPM10 fiber timing removal removal	DAQ cannot disable	---	DAQ recovers by itself at restart
Remove XPM10 fiber timing in the back while DAQ stopped	---	---	DAQ starts with no issue
Repeat XPM10 fiber timing removal removal while DAQ stopped	---	---	DAQ starts with no issue
Remove transceiver from XPM10 in the back (DAQ stopped)	---	---	DAQ starts with no issue
Remove transceiver from XPM10 in the back (DAQ started)	---	---	DAQ starts with no issue
	timing 1 shutdown by itself	TXlinkReset on XPM10 for XPM11	DAQ recovers
Remove fiber on XPM10 to XPM11	---	---	DAQ starts with no issue

Remove transceiver on XPM10 to XPM11	---	---	DAQ starts with no issue
Remove fiber on XPM11 AMC0 port 0	---	---	DAQ starts with no issue
Remove transceiver on XPM11 AMC 0 port0	---	---	DAQ starts with no issue

opal disappears from the list f detectors	restart DAQ	DAQ starts with no issue
power cycle xpm10 via switch only AMC0	XPM 11 loses timing node Opal not in the list of detectors	Restart pyxpm 10 and 11 Power cycle xpm 11 with handles fru-deactivate xpm11 (3 times) fru-deactivate xpm10  restart pyxpm 11	DAQ restarts but opal shutdown
	opal still shutdown	devGui xpmmini timing v2 TxLinkReset Opal still not back BadDetector Paddr Xmpva died xpm11	no avail
		Stop pyxpm 10 and 11 fru-deactivate 10 and 11 strat pyxpm 10 and 11	DAQ starts with no issue

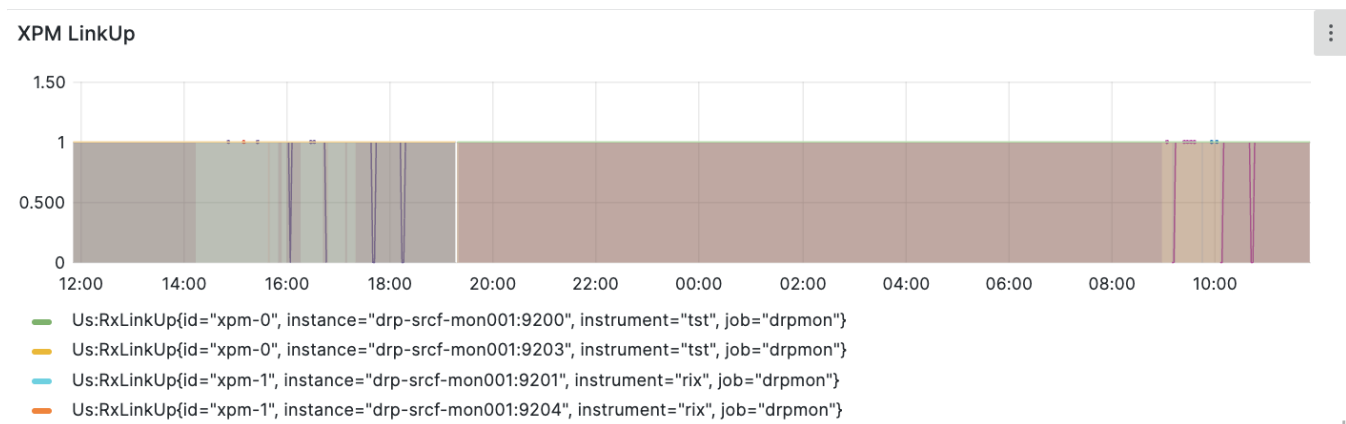
## Observation Of Front-Panel XPM Link Glitch With Version 3.5.4

Perhaps fixed by Matt in later firmware version?

XPM11 glitches between 4pm and after 6pm and also around 10:10 am the next day

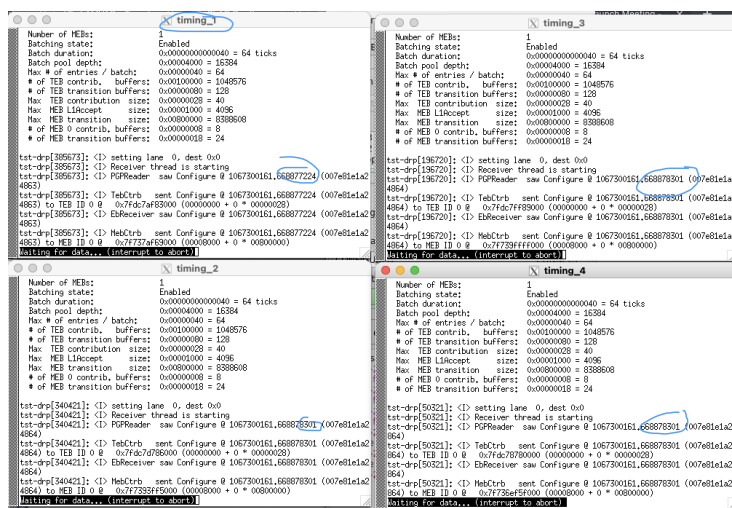
example of the timing shift in the timing nodes (before -D fakecam).
