# Acute SVT Sensor Damage Test Beam

# SVT Module Damage

# Summary of Notes, Observations, Ideas

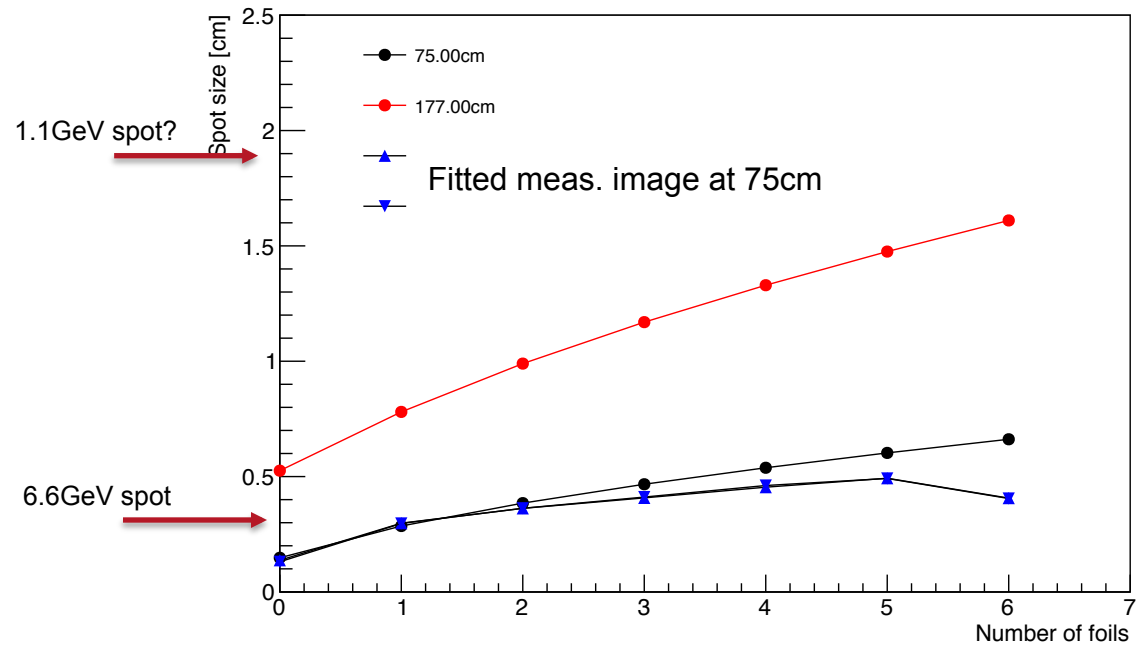
# Estimated and Measured Beam Spot

Agreement to measured within 20% up to 5 foils; not sure what happened at 6 foils

EGS agree to within 20-50% with this simulation...

At 177cm; probing ~1.1GeV spot size...

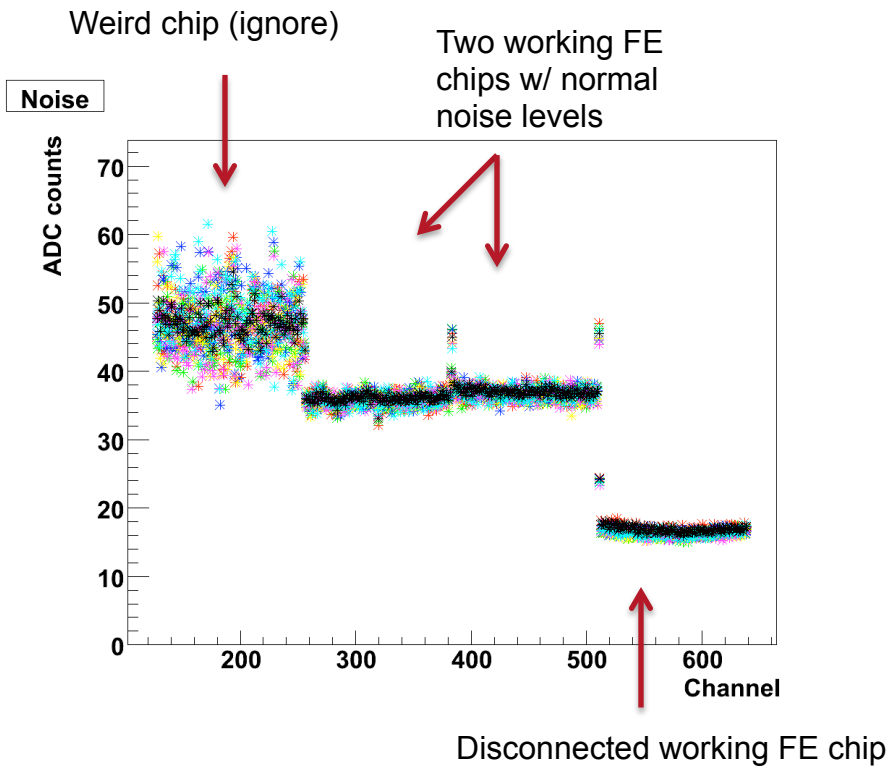
# Noise @ 1pC

1pC and 500V: no problems

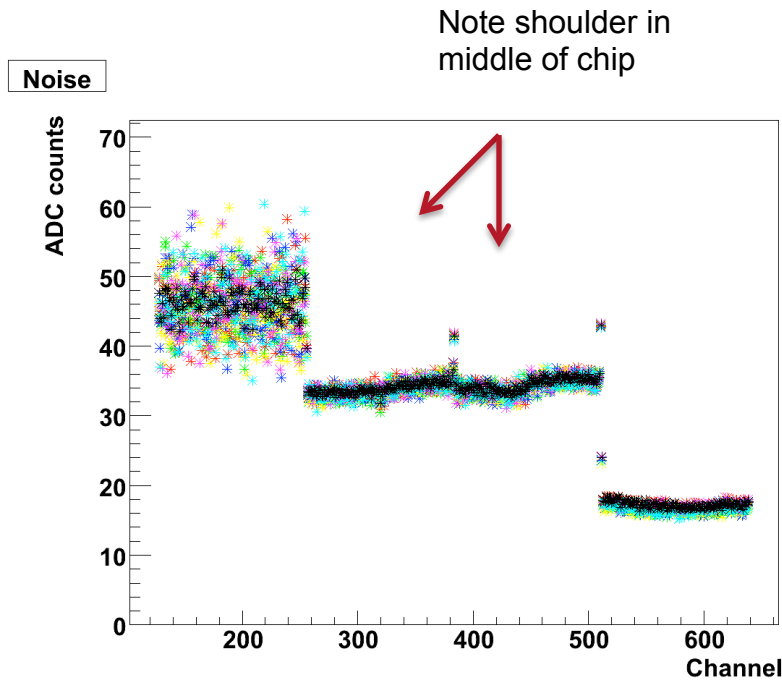
# Noise @ 10pC, 350V

10pC and 350V: first sign of issues

First damage sign at 10pC (350V); roughly  $10^5$  e-/strip

Shoulder on noise across both FE chip channels (not seen before); increasing with higher bias and bunch charge

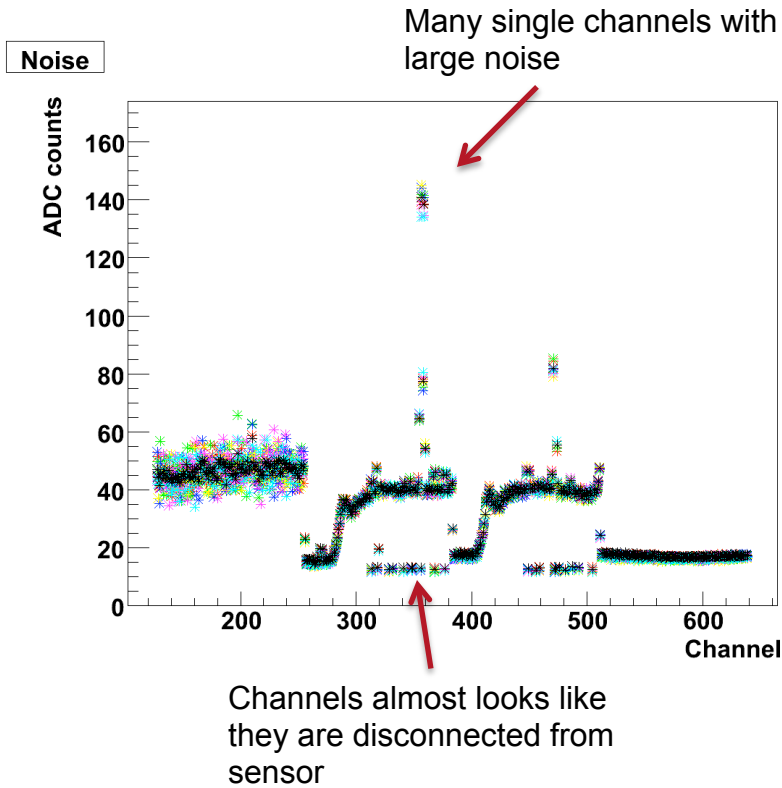
# Noise @ 100pC, 350V

After 100pC and 350V, roughly  $10^6$  e-/strip, see many individual channels with high noise (pinholes?) and some look disconnected

1 hypothesis: many adjacent pinholes may need chip to swallow large DC current which could affect the chips inner structure.

Lab tests on irradiated module should give definitive clues to understand the cause of failure
