# Preliminary characterization of microstrip detectors for HPS experiment

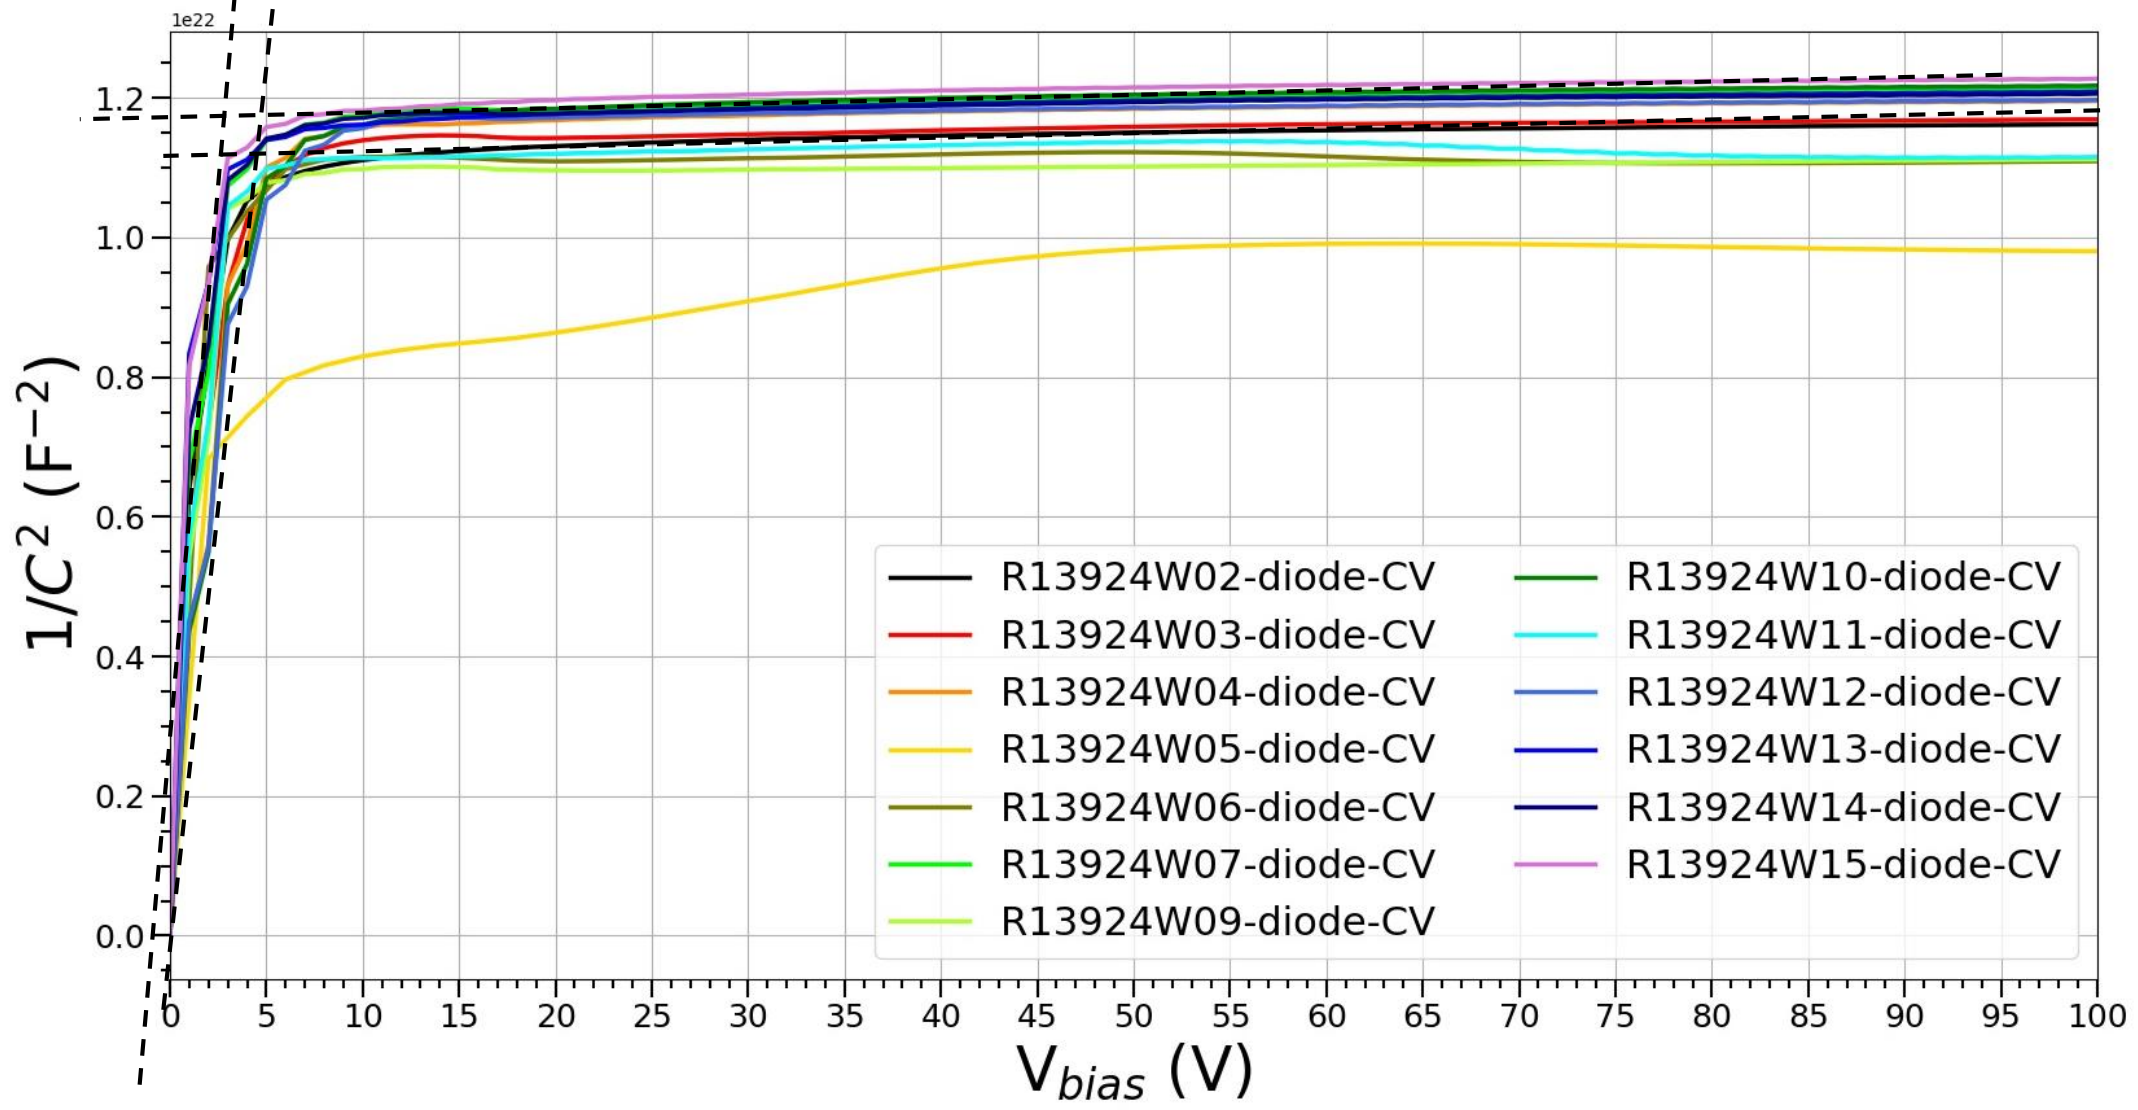
$1/C^2$  measured on wafers (diodes) before dicing: depletion voltage < 5 V

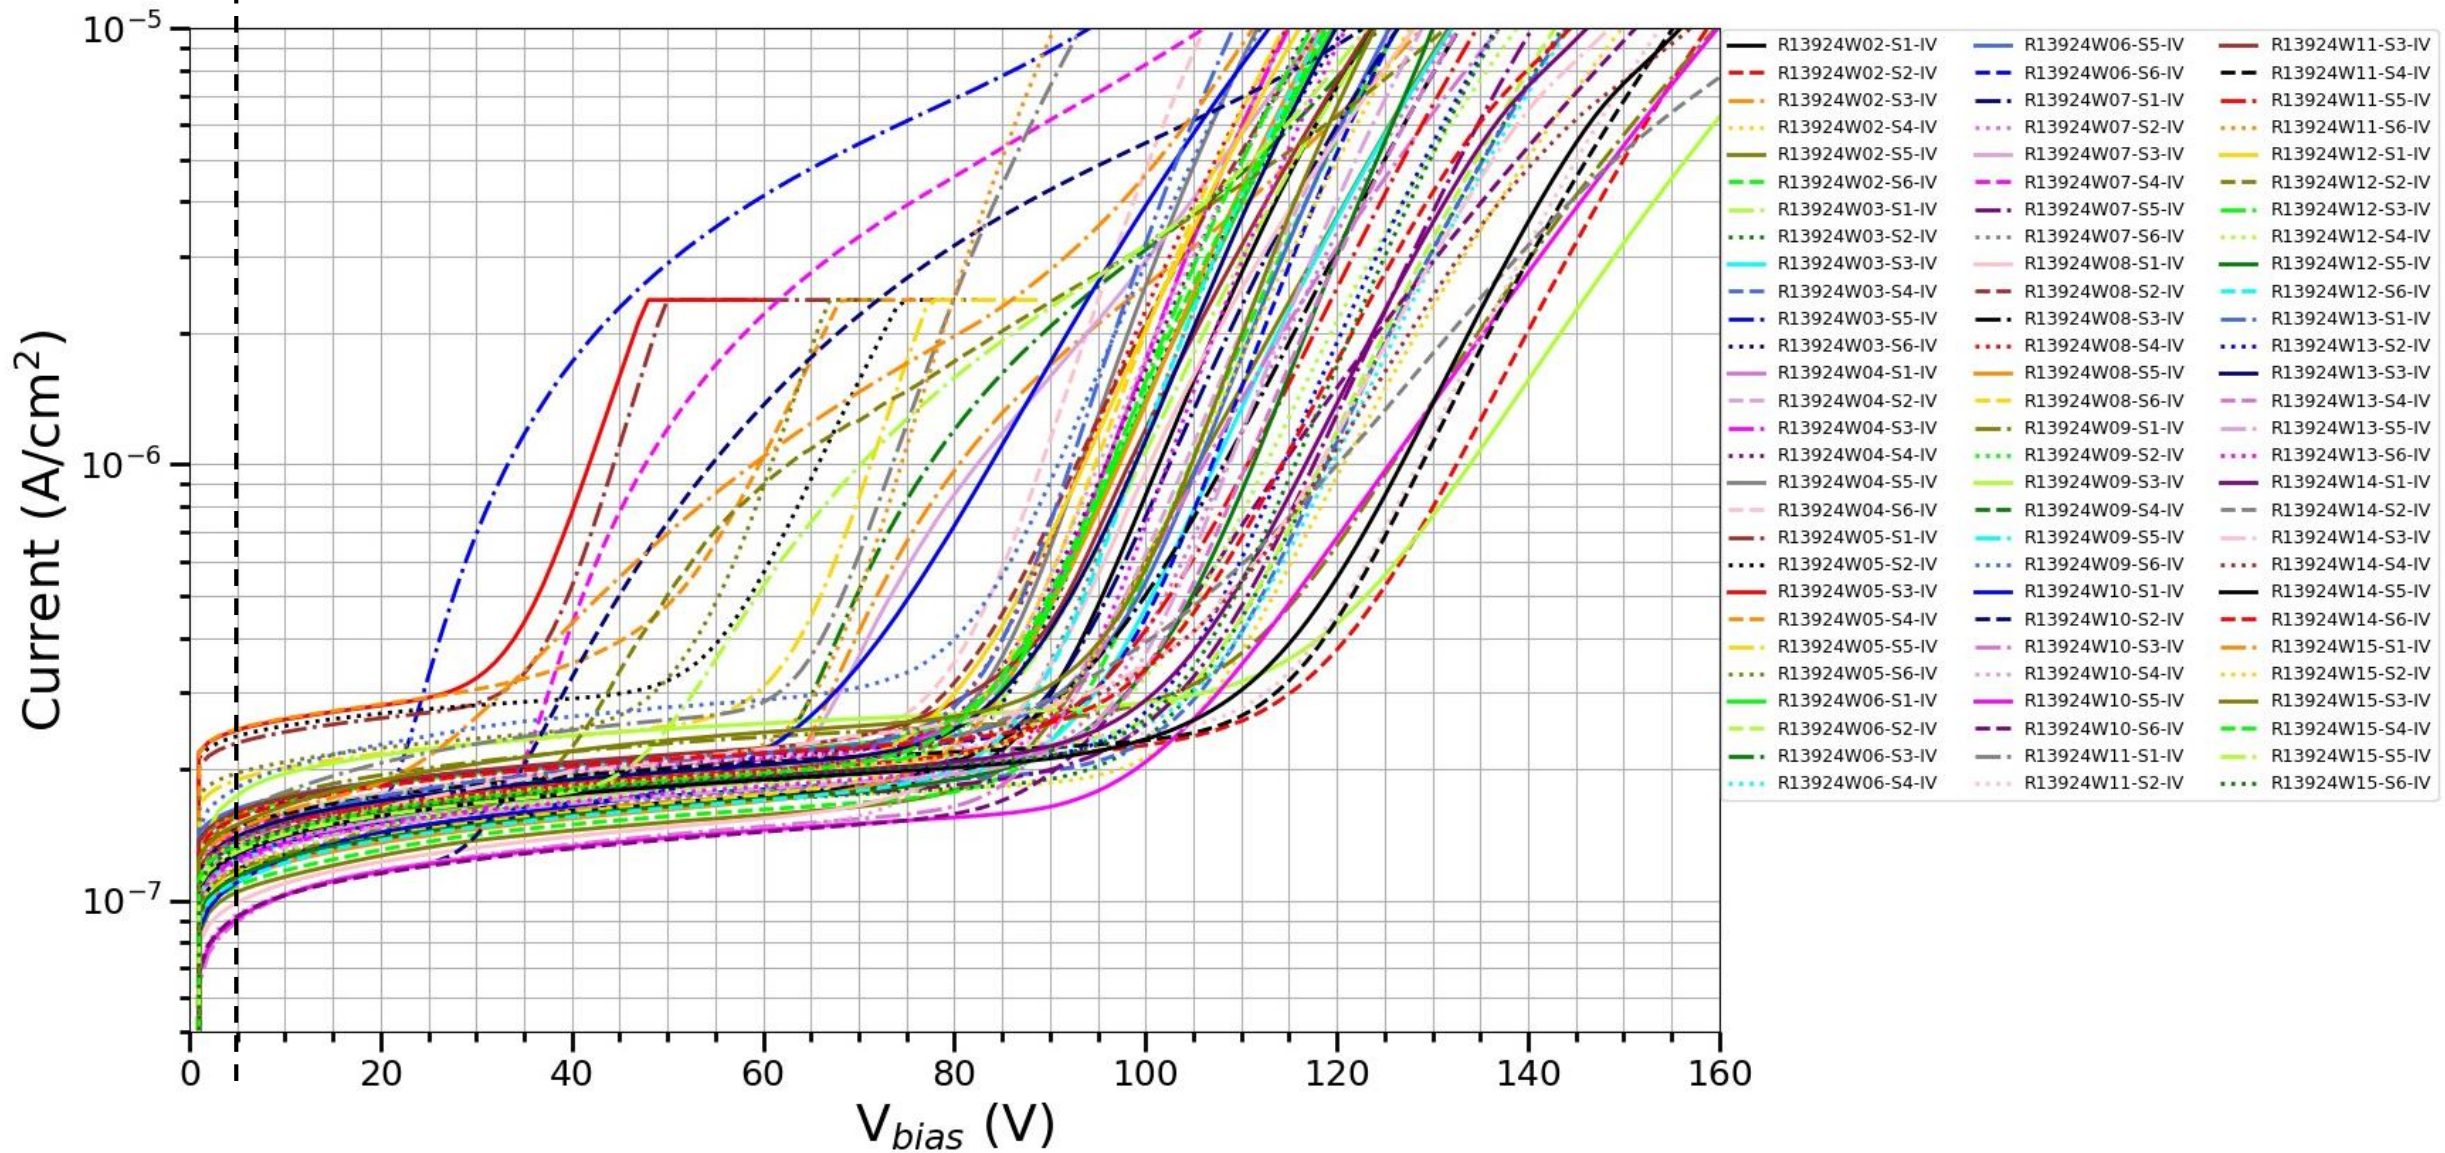
IV characteristic measured on detectors on wafers before dicing

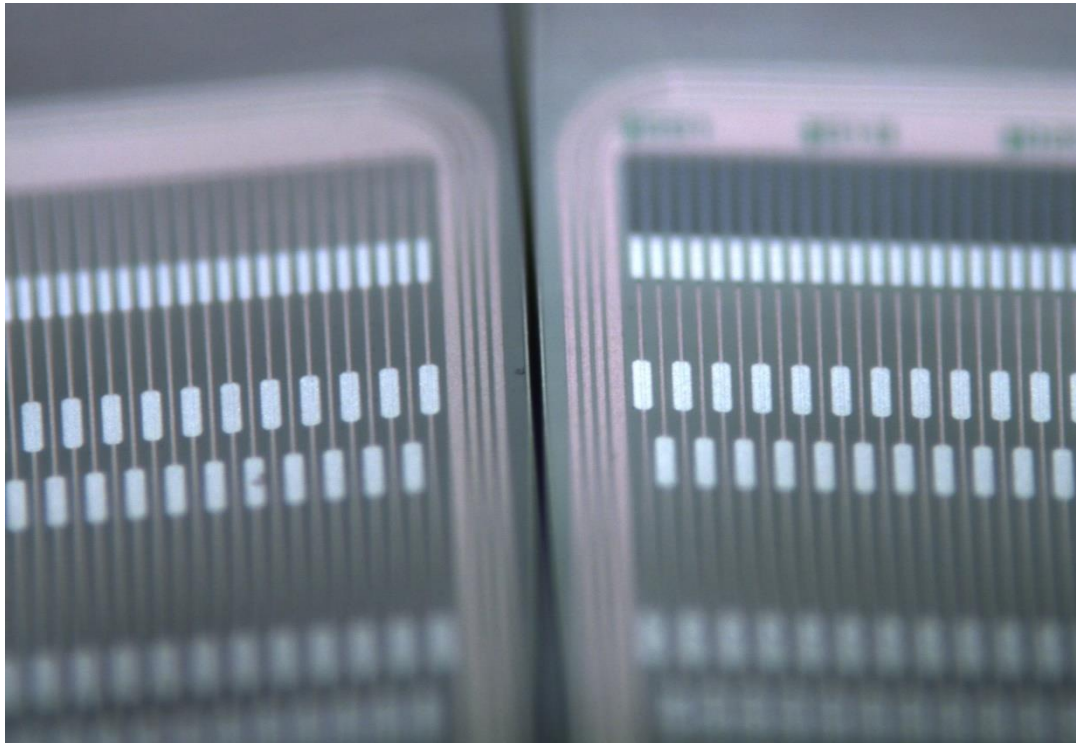
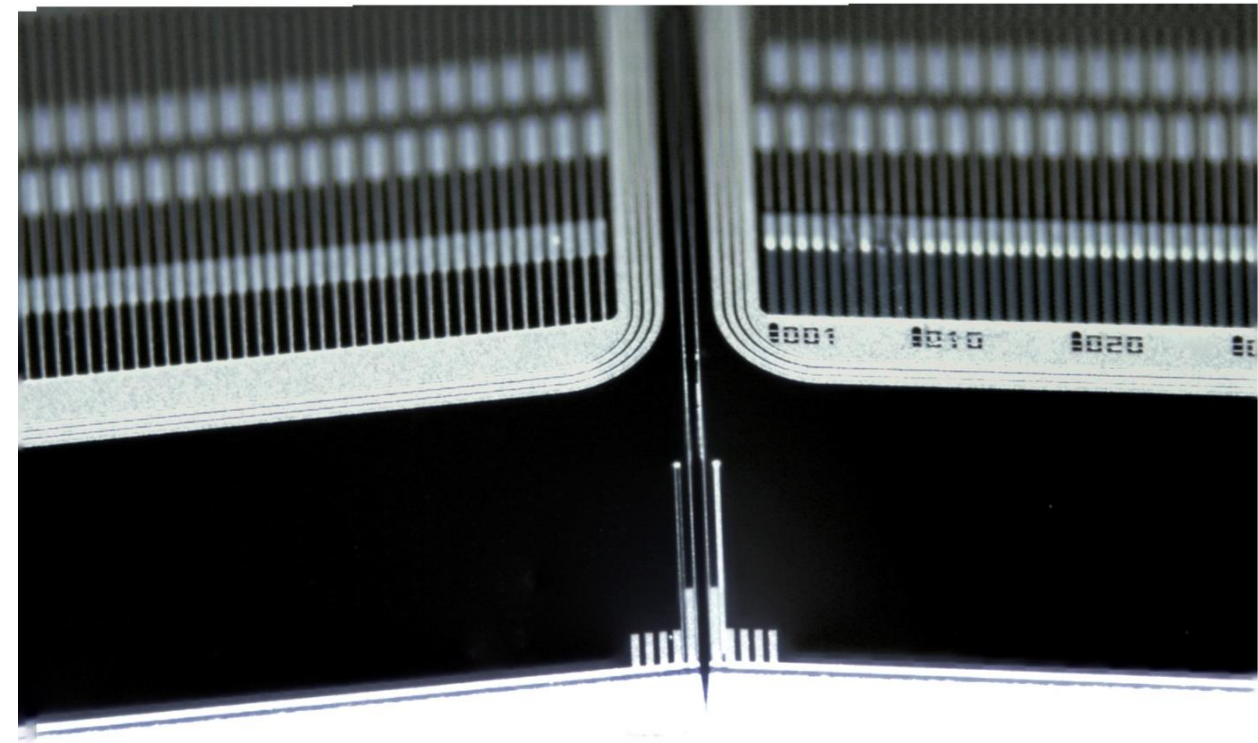
Cleaved edge is perfectly along the cleaving path 250  $\mu\text{m}$  far from the active area. Design alignment better than 0,1 degree

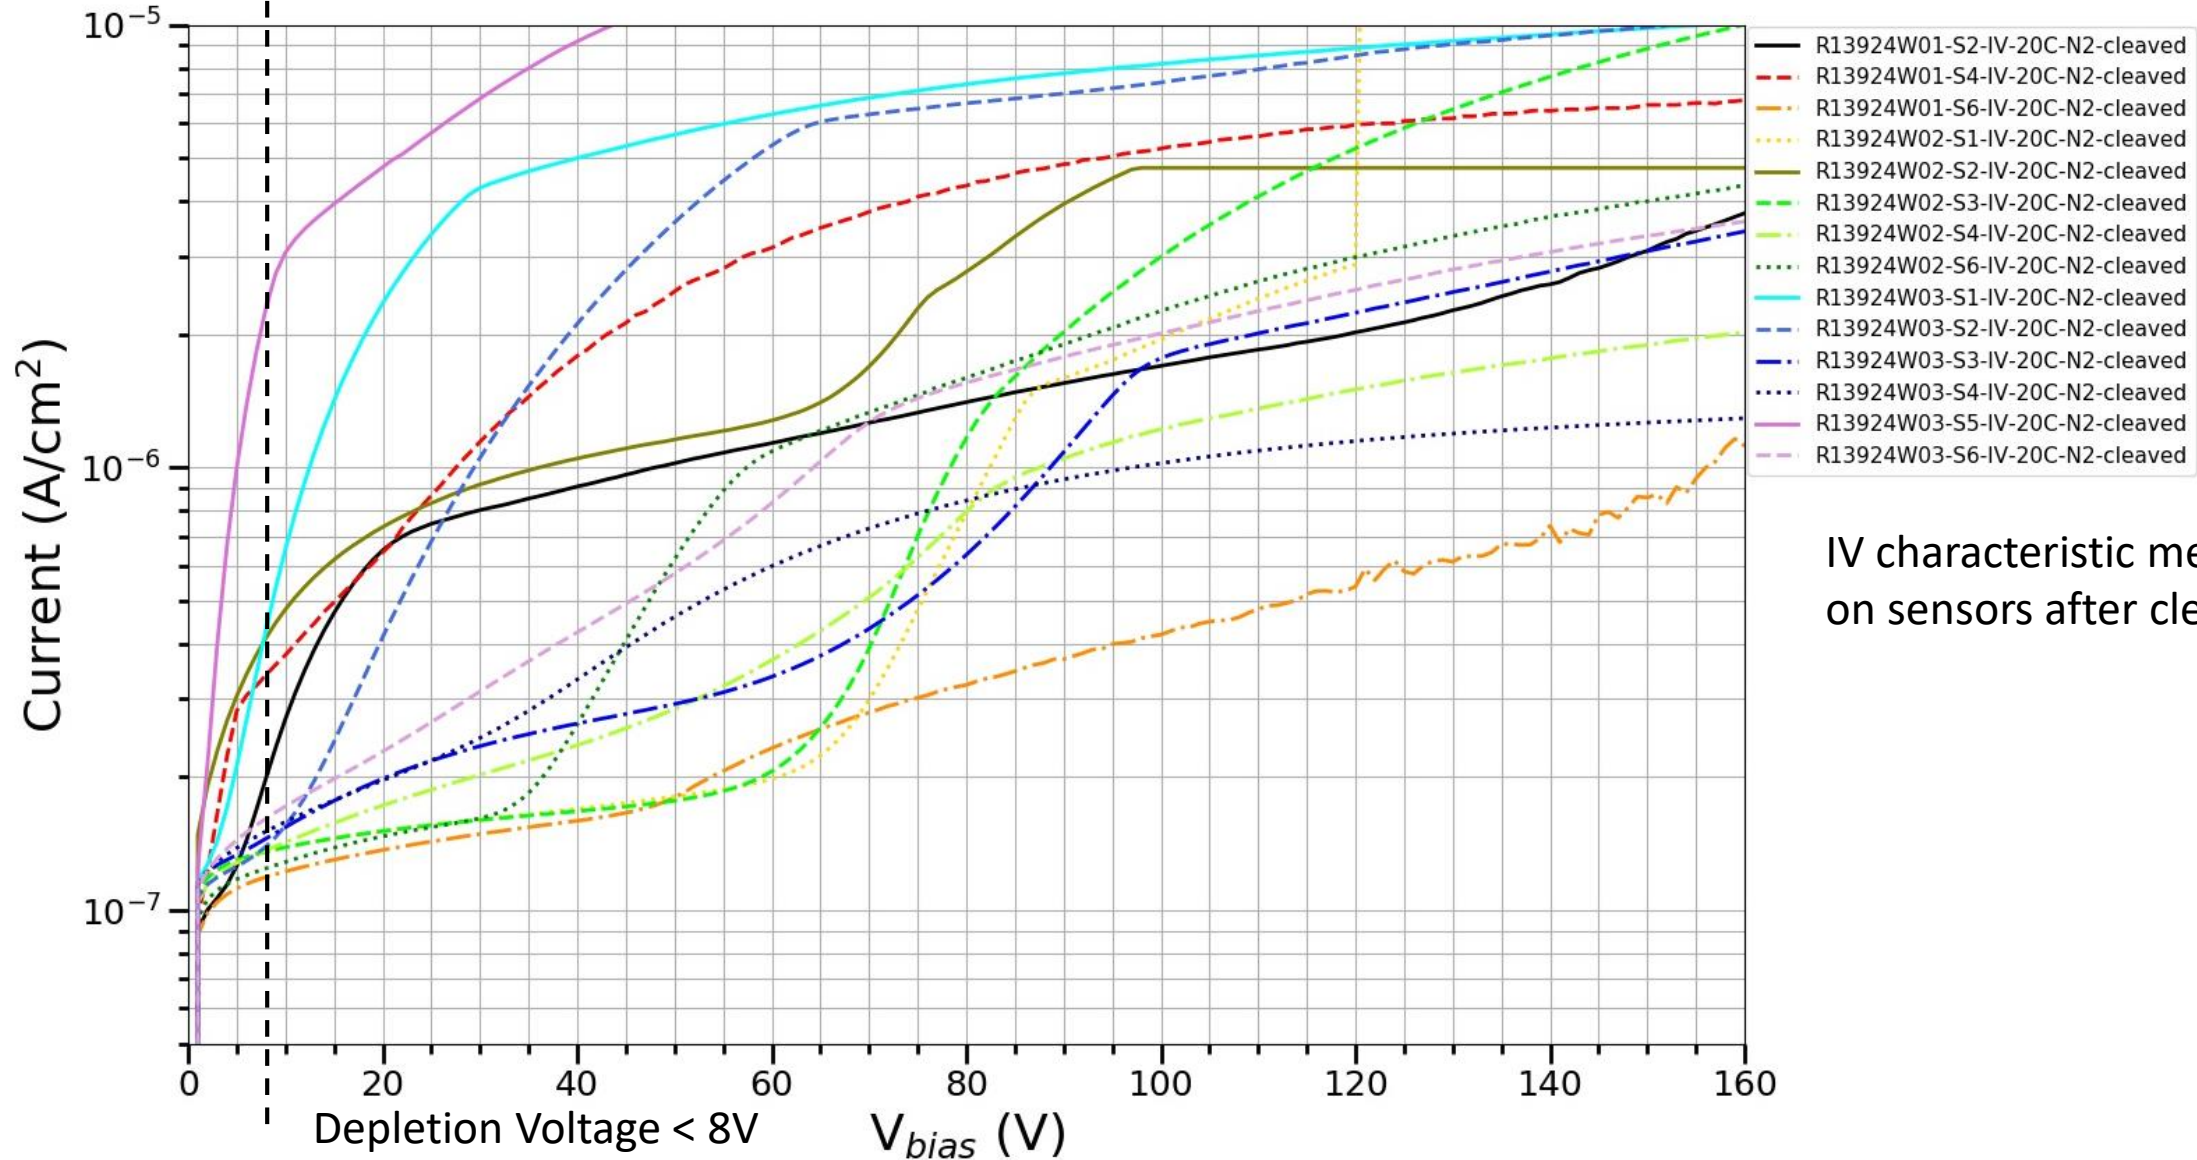
IV characteristic measured on sensors after cleaving

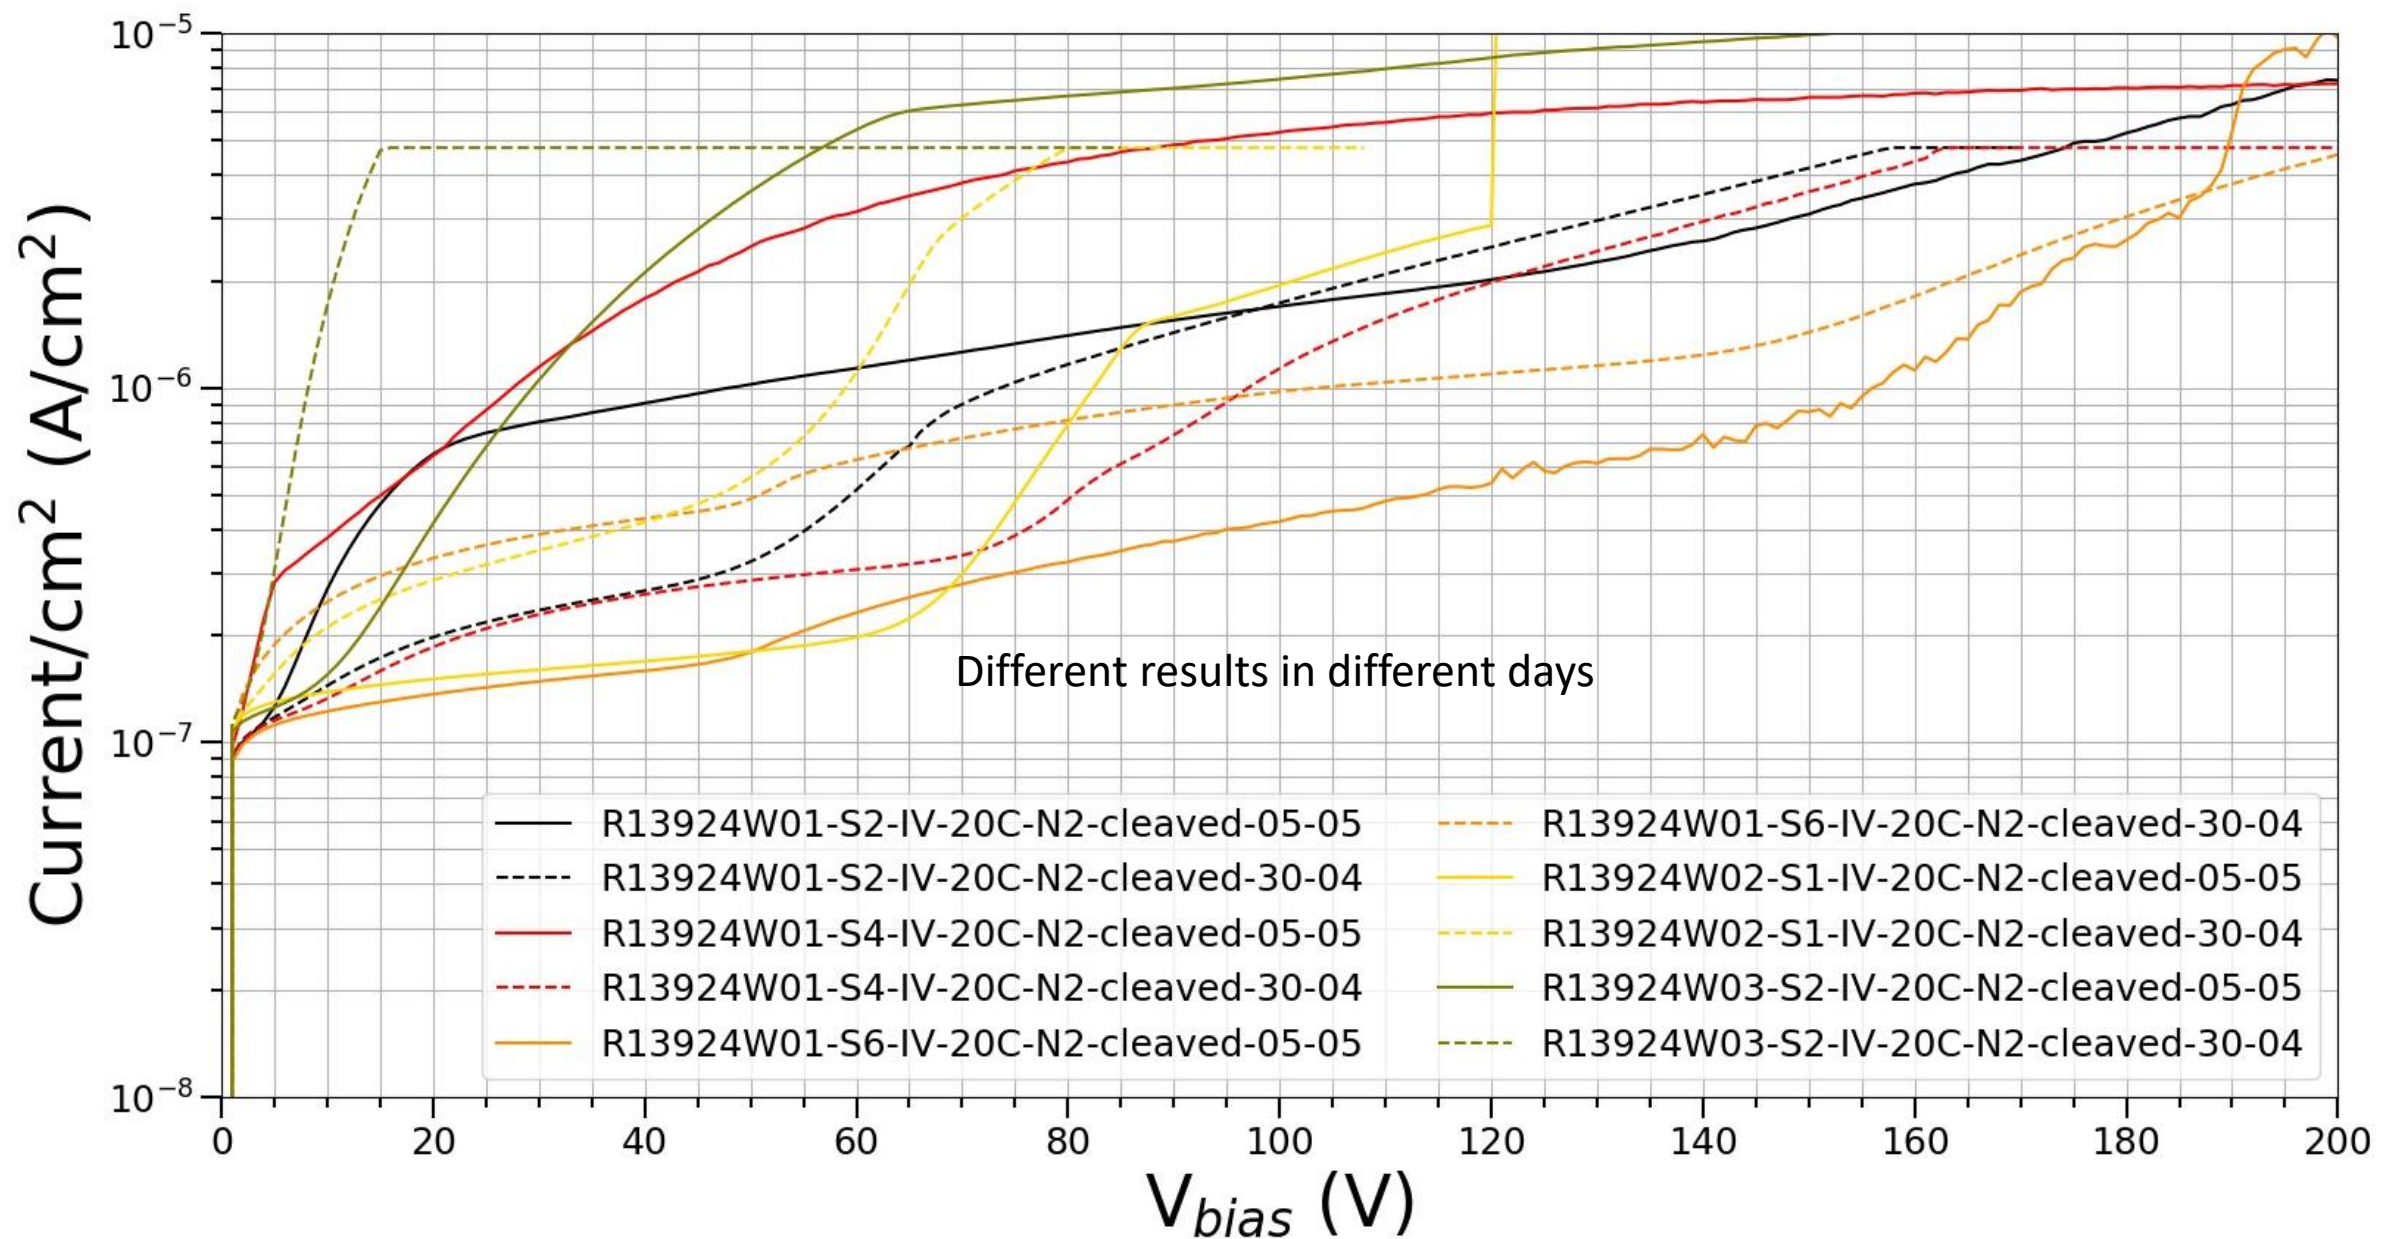
Current evolution in sensor W02 S1 at different stages
