BESIII RPC Aging Study

Changguo Lu
Princeton University

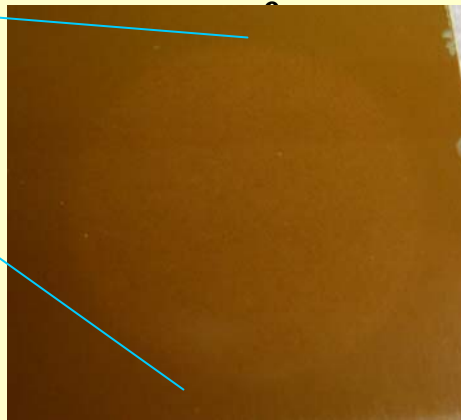
Brown side of Bakelite plate shows slightly discolored mark.

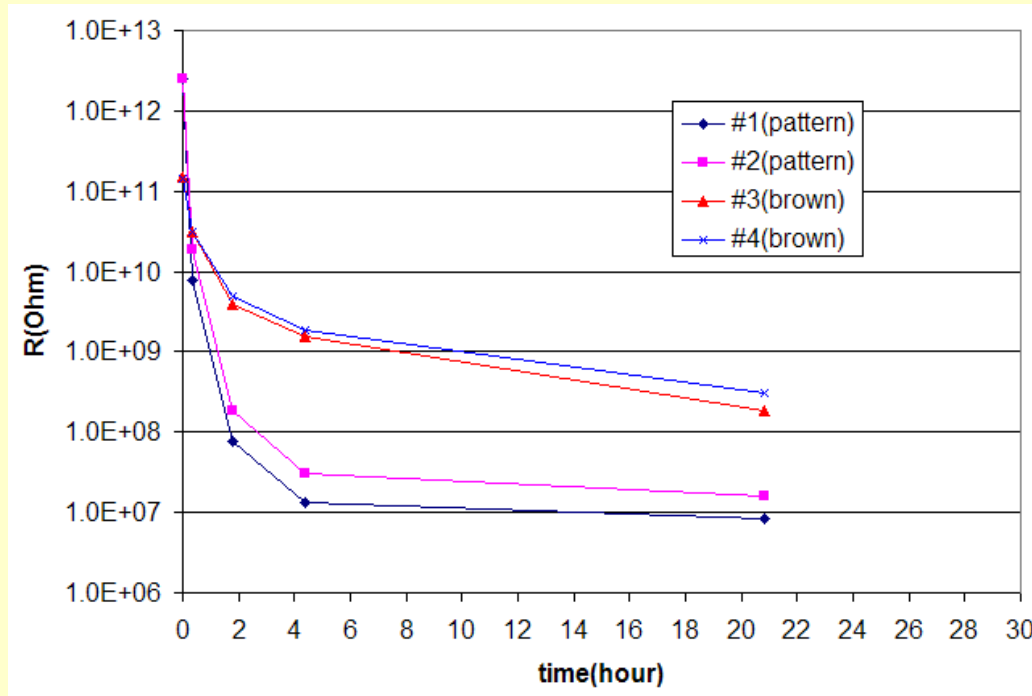
Effect on BaBar Bakelite surface (contd.)

At the very beginning of exposure the surface resistivity drops very fast, then slow down.

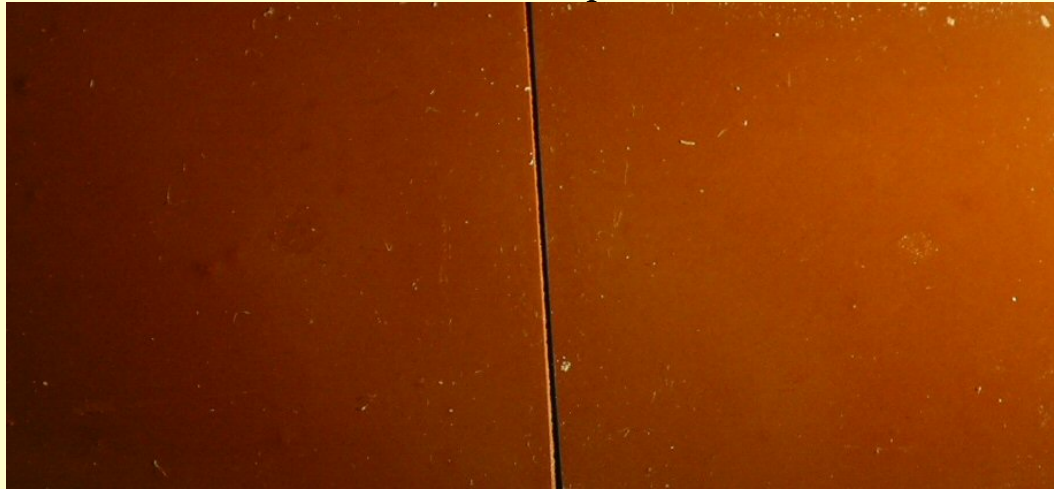
Effect on Linseed oil coated Bakelite

The Linseed oil coated Bakelite surface is much better protected from HF vapor attack. After 24 hours of exposure there is no discolored area can be seen.

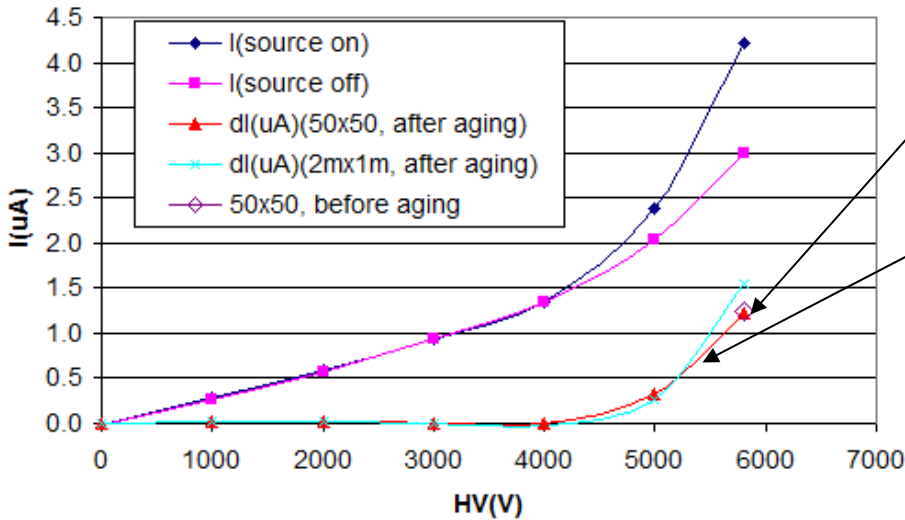
Aging chamber dark current at 5800V, w/ and w/o source.

Before aging

After aging

There is no noticeable change after the first round aging test.

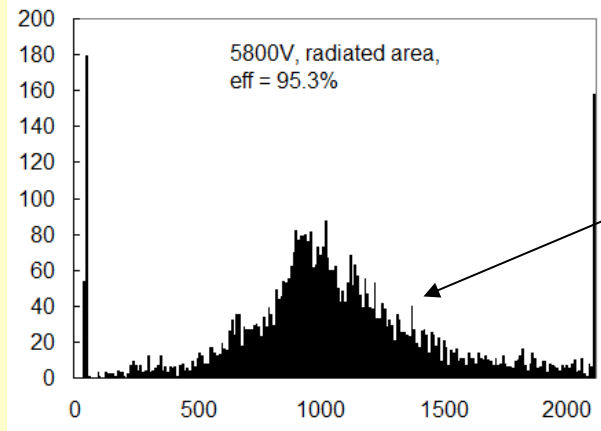
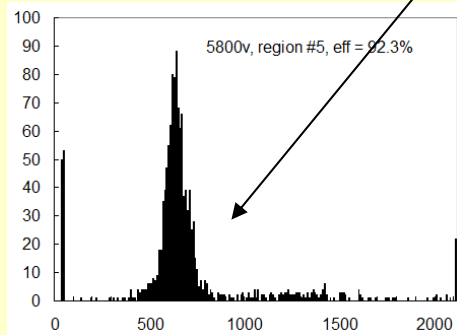
We also measured the peak spectrum for 9 regions.

A noticeable spectrum distortion can be seen for the aged region #1. The spectrum on radiated region shows a very broad distribution, although the efficiency is still high, but the distorted spectrum may reflect the aging damage to the internal electrode.

The other two spectra, triggered on the unirradiated regions, show a narrow distribution, which is a typical streamer distribution.

We didn't record the peak spectrum before the aging, not sure if this is solely due to the aging, or may be just due to the bad region originally.

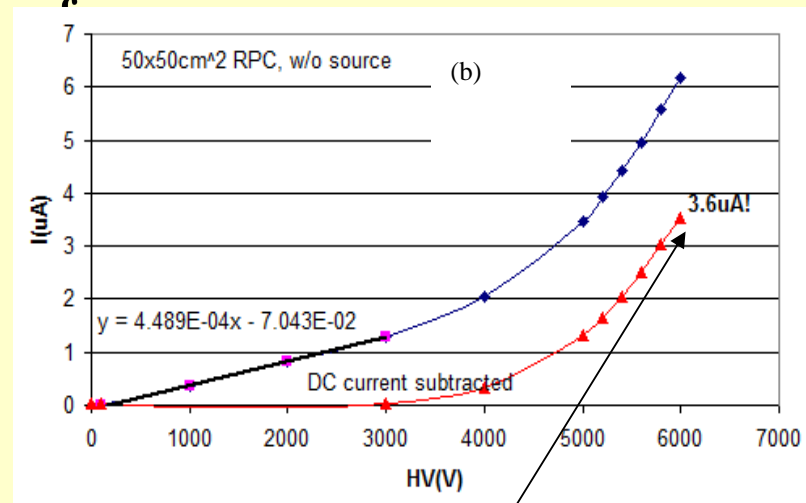
Aging RPC, 3.6 μA @6000V, w/o source.

After only 16 days another aging effect appeared: **the dark currents on two RPCs became different.**

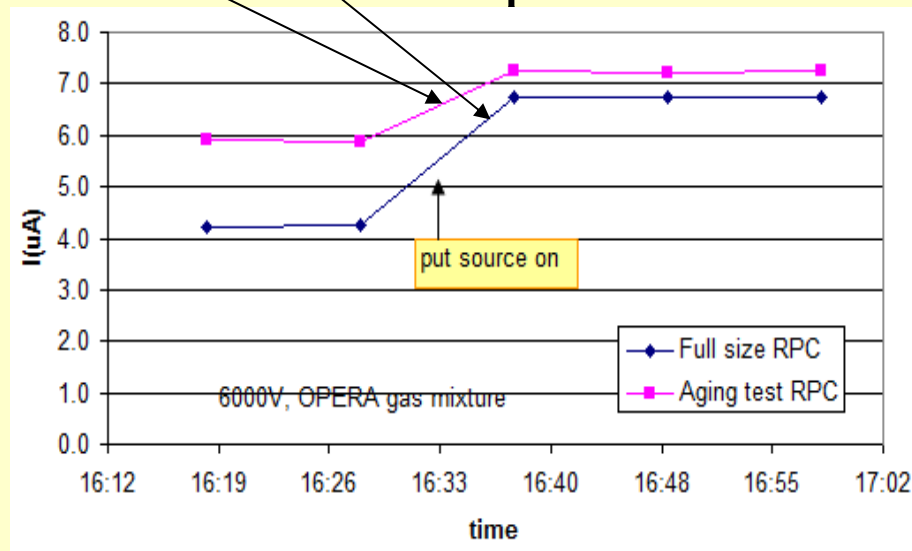
In addition, the current jump due to the source was now smaller for the small RPC. On 9/3/2008, the 16th day in the second round of aging, the current in the small chamber jumped from $5.89\mu\text{A}$ to $7.25\mu\text{A}$, so $dI \sim 1.36\mu\text{A}$, but the current in full-size RPC jumped from $4.26\mu\text{A}$ to $6.74\mu\text{A}$, for $dI \sim 2.48\mu\text{A}$.

Apparently the aging RPC had higher background current, which very much likely was due to the damaged Bakelite inner surface.

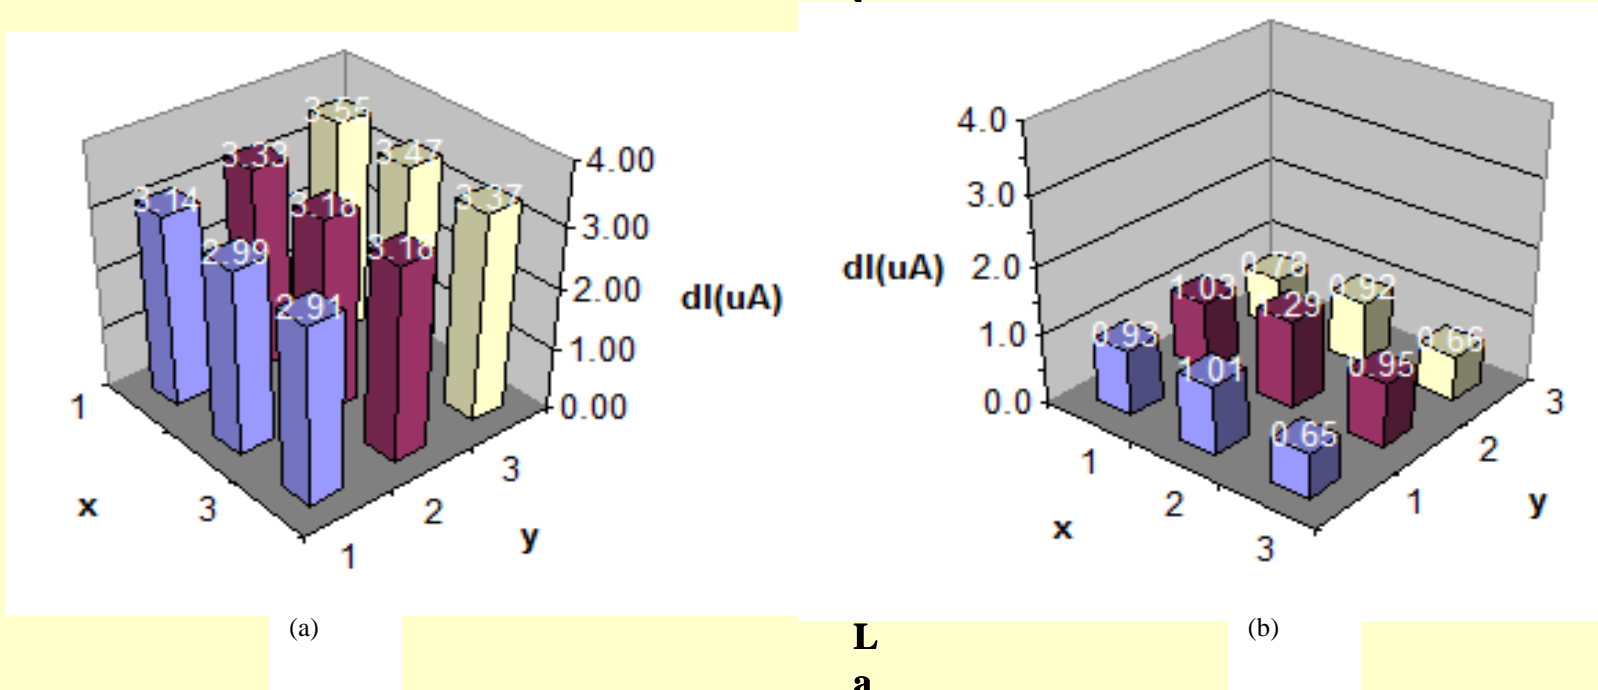
Dark current jump map after 2-nd round aging

At the end of the second round of aging we surveyed the dark current response in 9 regions. By placing the source on each region and measuring the dark-current jump dI_a

Full size RPC, dI larger, small relative variation.

Aging RPC, dI much smaller, larger relative variation.

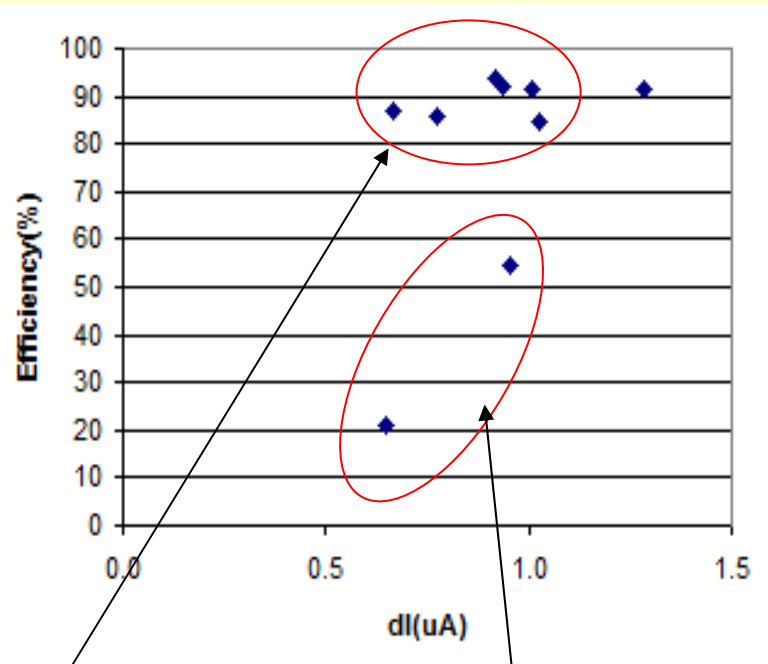
Scatter plot of efficiency vs. current jump, dI , for 9 regions.
