# p19-0 stave anatomy

## Fully loaded stave, 16 Sep 2021

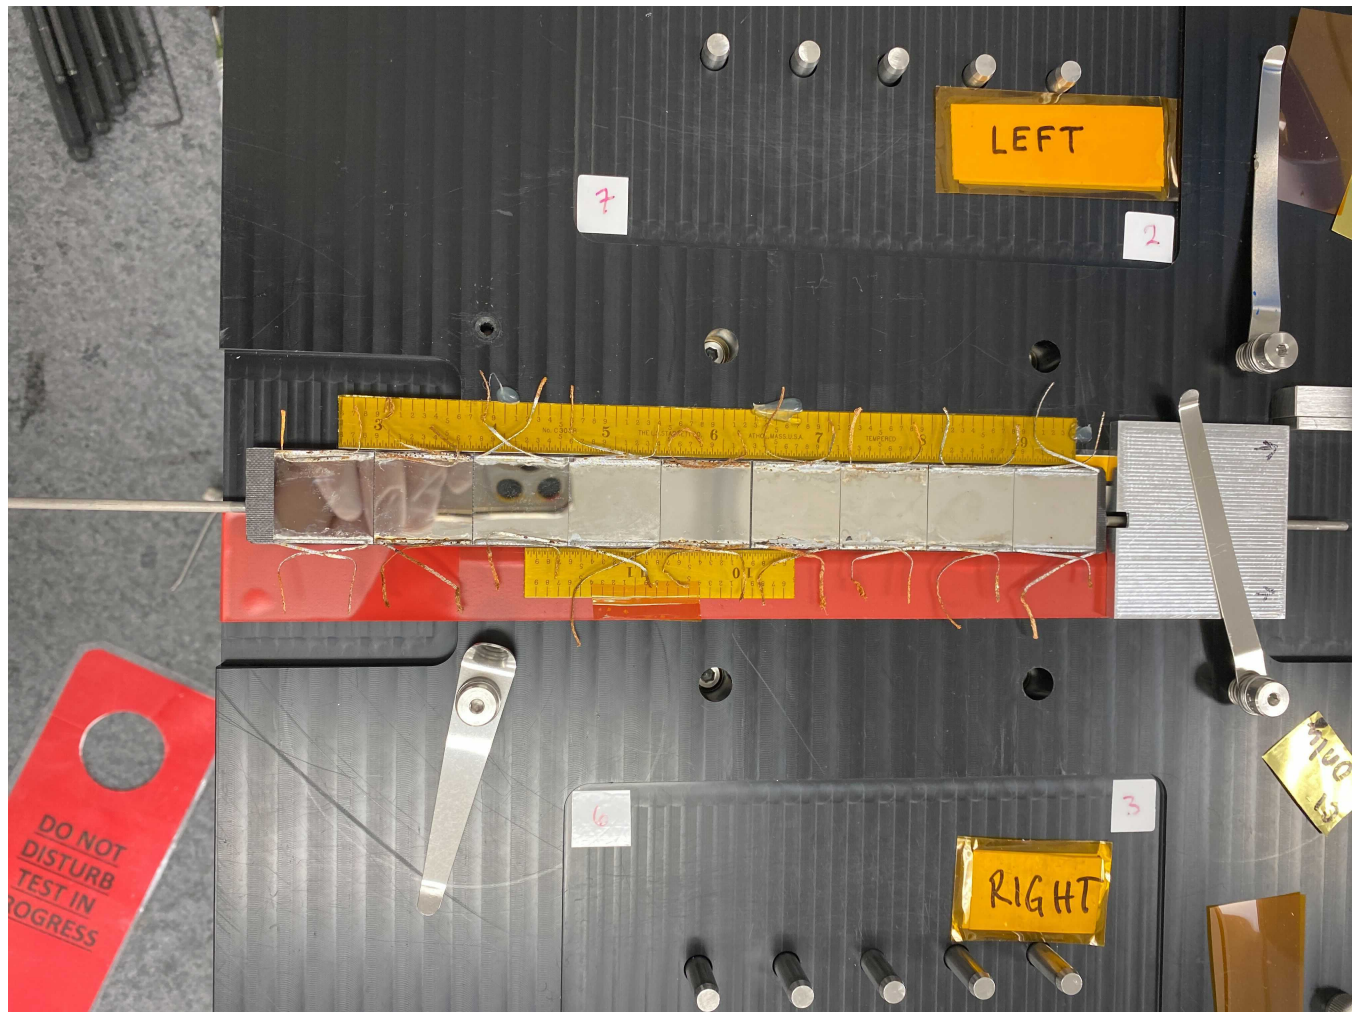
Module positions: We number the modules 1-9 from left to right in this image

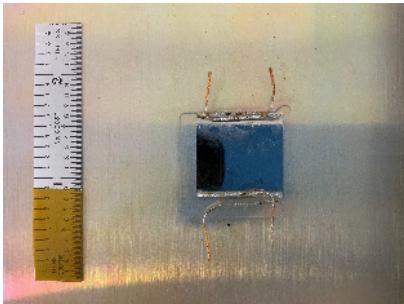
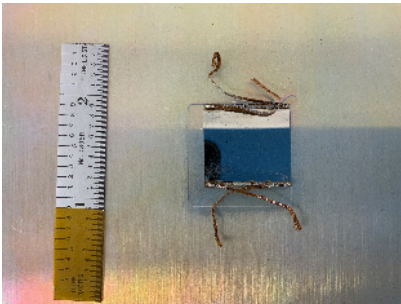
| Before IPA wash | <ul style="list-style-type: none"> <li>• ethanol wash!</li> </ul> | | |

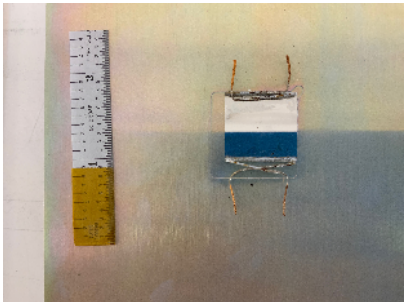
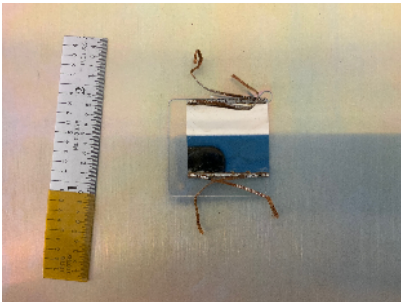
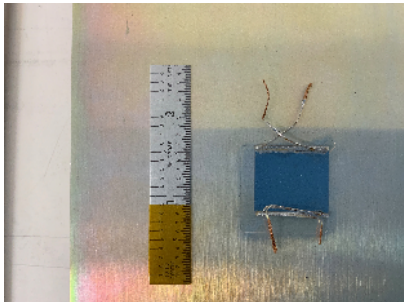
| After IPA wash | <ul style="list-style-type: none"> <li>• ethanol wash!</li> </ul> | | <p>Wires too sensitive for more cleaning</p> |

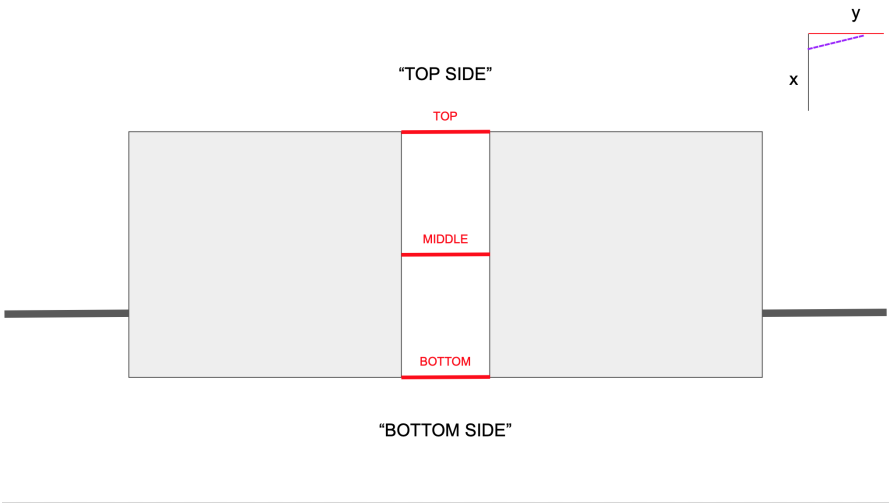
Metrology results with the CMM

DISTANCES (MICRONS)

| Area | C1S1-C1S2 | C1S2-C1S3 | C1S3-C1S4 | C1S4-C1S5 | C1S5-C2S2 | C2S2-C2S3 | C2S3-C2S4 | C2S4-C2S5 |
|---|---|---|---|---|---|---|---|---|
| TOP | 220 | 300 | 44<br>(OVERLAP) | 131 | 518 | 19 | 230 | 58 |
| MIDDLE | 215 | 284 | 50 | 134 | 477 | 83 | 173 | 76 |
| BOTTOM | 210 | 269 | 86 | 140 | 437 | 153 | 117 | 104 |
