Gimp Testing Update

Heavy Photon Search SVT Meeting

Testing Overview

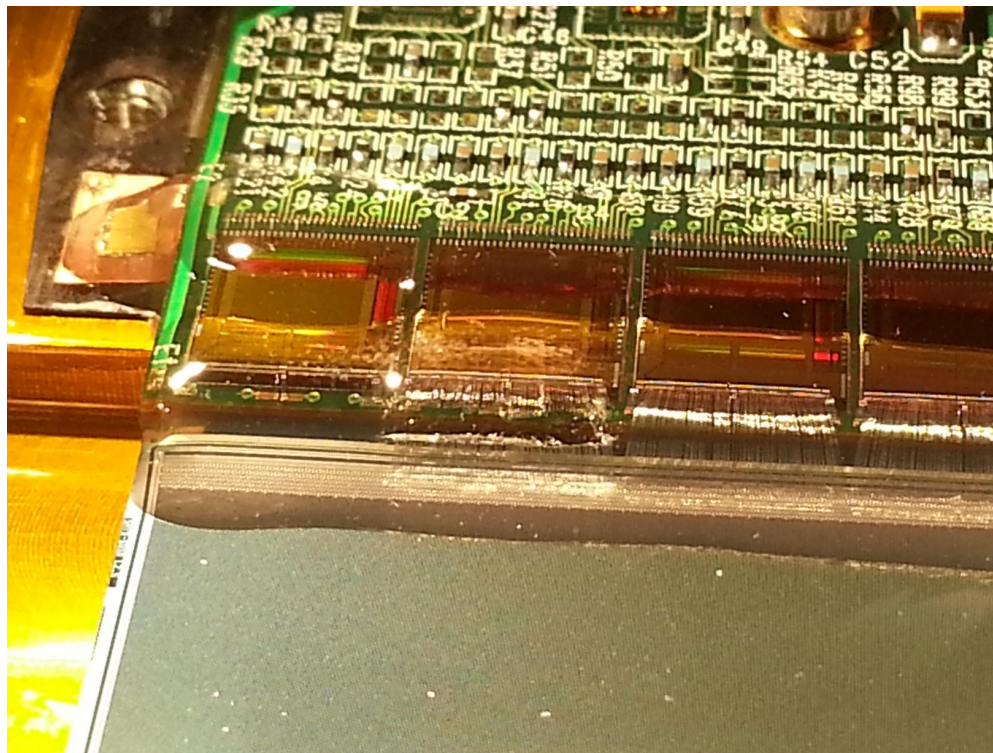
- ❖ Removed wirebonds from the APV25 nearest the unbonded APV25

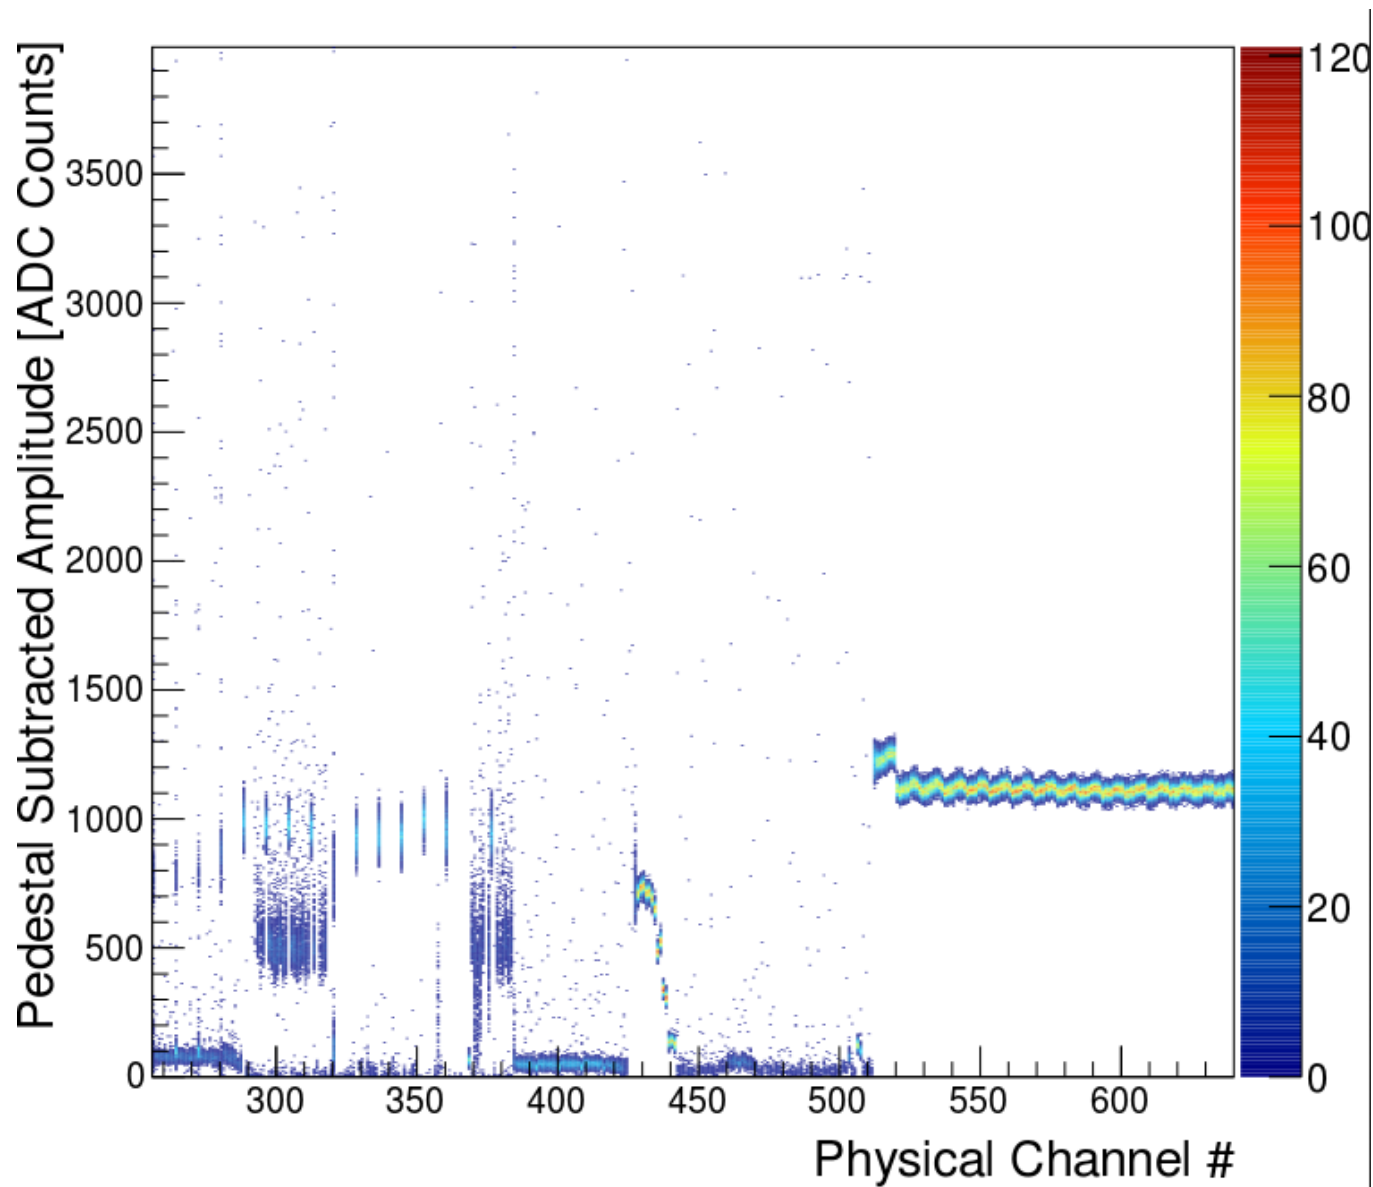
Calibration Response Overview

- ❖ The channels of the APV with pulled wirebonds do not respond to a calibration pulse
 - Seems to be indicating that the chips are dead
 - Trying to understand the noise pattern is irrelevant at this point
 - Sensor may or may not be damaged; It's hard to tell without IV curves taken before the test
