# Acute SVT Sensor Damage Test Beam

# SVT Module Damage

# Summary of Notes, Observations, Ideas

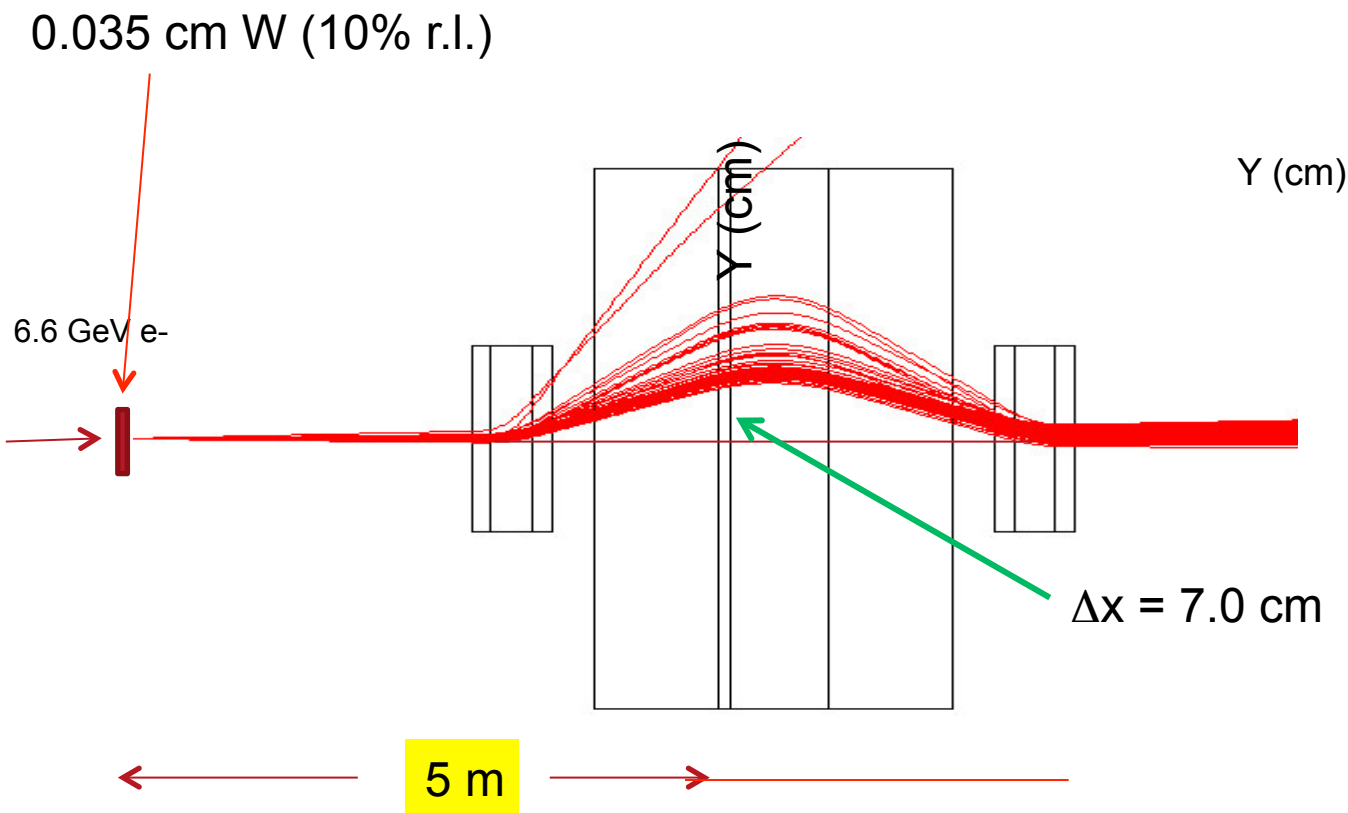
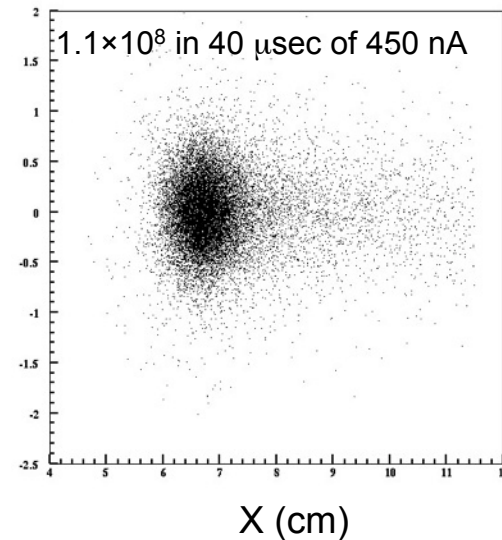
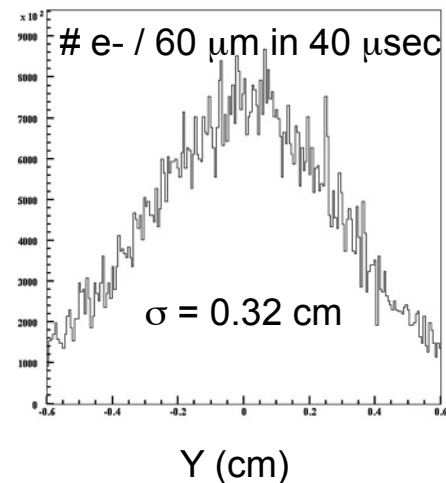
Expect maximum of  $8 \times 10^5$  electrons/ strip / 40usec

Spot size is  $\sim 0.32\text{cm}$  width

No time evolution – static for 40usec for this example (?)

Are the SVT modules safe for this type of accident?

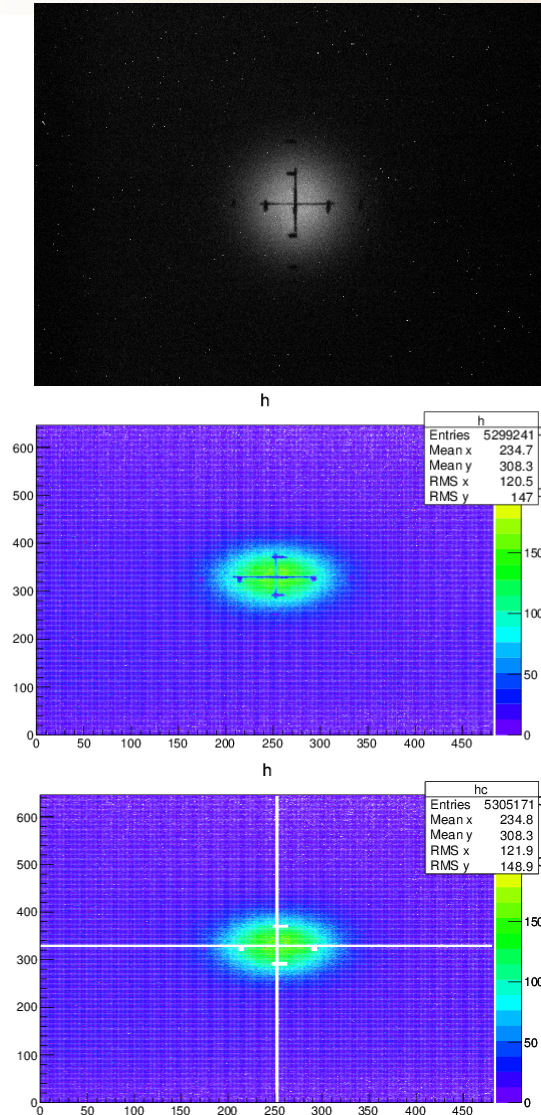
Agreement to measured within 20% up to 5 foils; not sure what happened at 6 foils

EGS agree to within 20-50% with this simulation...

At 177cm; probing ~1.1GeV spot size...

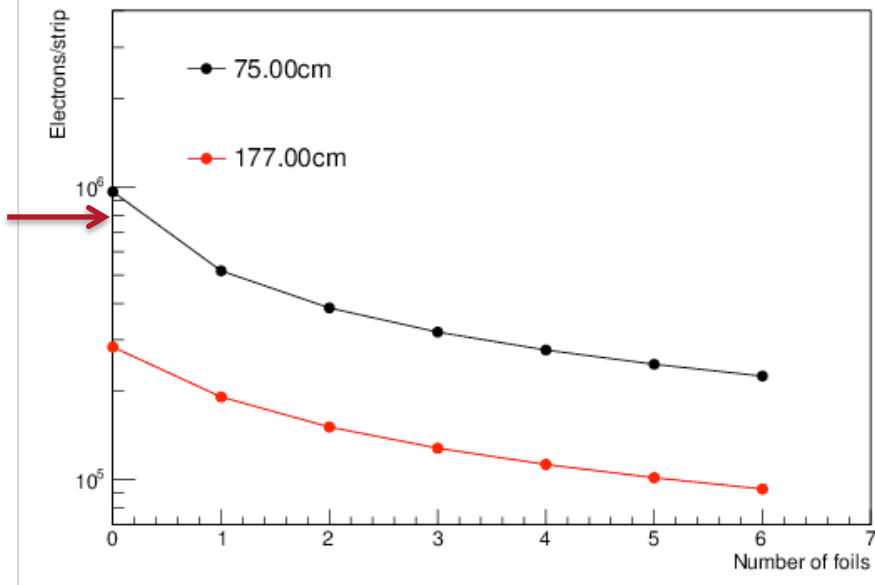
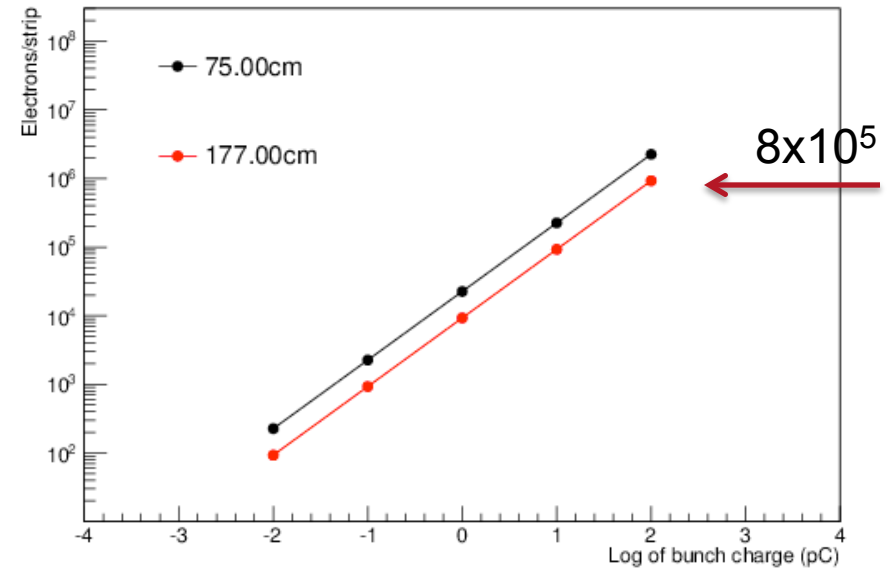
Scan orders of magnitude using beam current

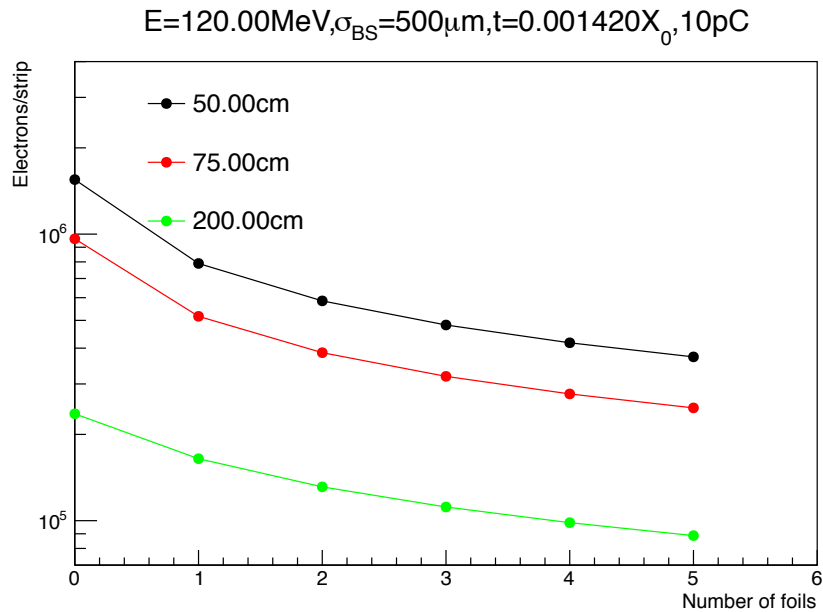
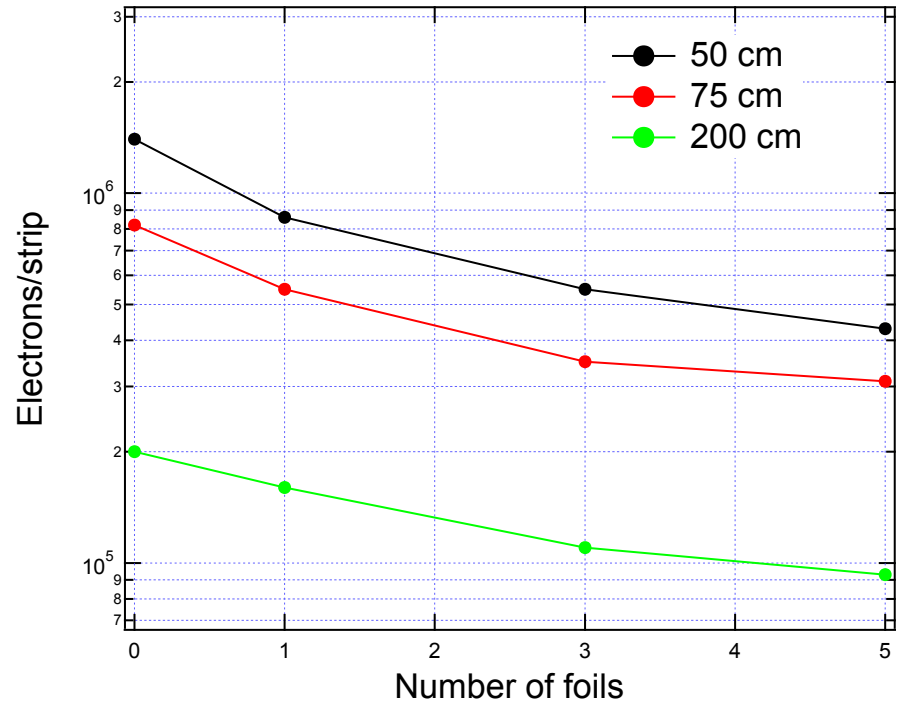
Agreement to within 20-50%
