# ESTB 2016/July T539 + T545

ATLAS twiki page for T539: <https://twiki.cern.ch/twiki/bin/viewauth/Atlas/RadDamageTBSpring2016>

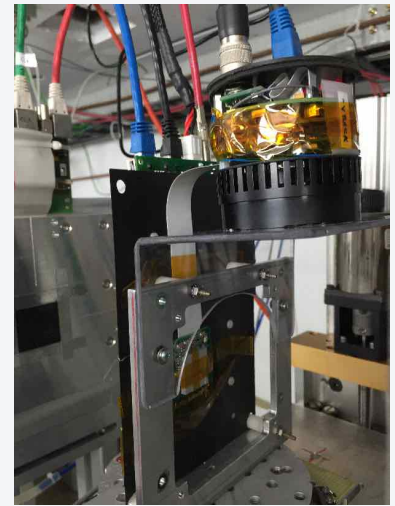
Maurice's CMOS sensor shipped to SLAC from Sensor Creator's Inc directly. A 'camera' like standalone readout unit connecting the sensor via a thin flex. Beamline support scheme worked out with Matt McCulloch with CMOS sensor taped behind the 94-04-03 double chip FE-I4 module. Vertical readout chain to allow easy rotation. Ethernet port address 192.168.2.1.

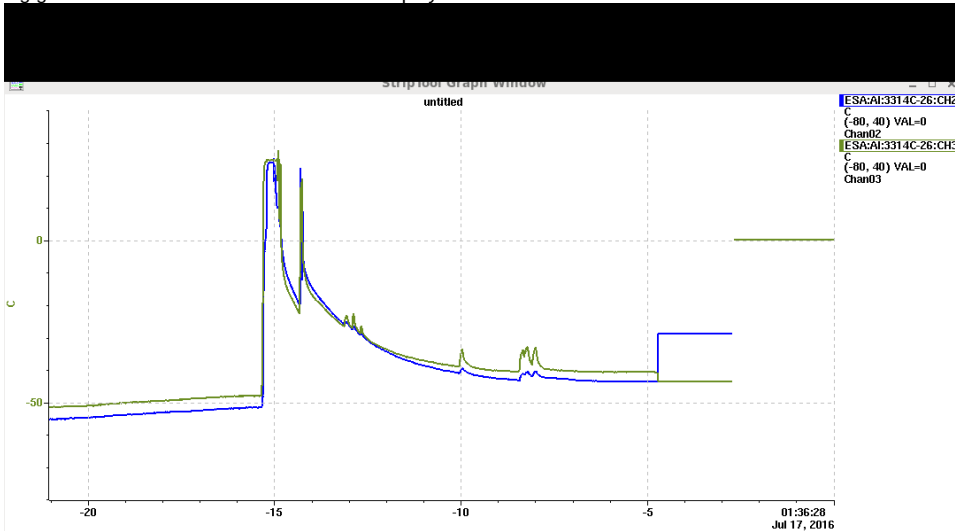
- Concluded the day with just two good tilted runs with LUB1 @ 1.1KV.
- The temperature time history below for July/16 showing initial blue=probe tied to DUT Cu tape, green=cold box gas. The step at  $t=-5$  hours is the big glitch that took out the Caladium drive/display.

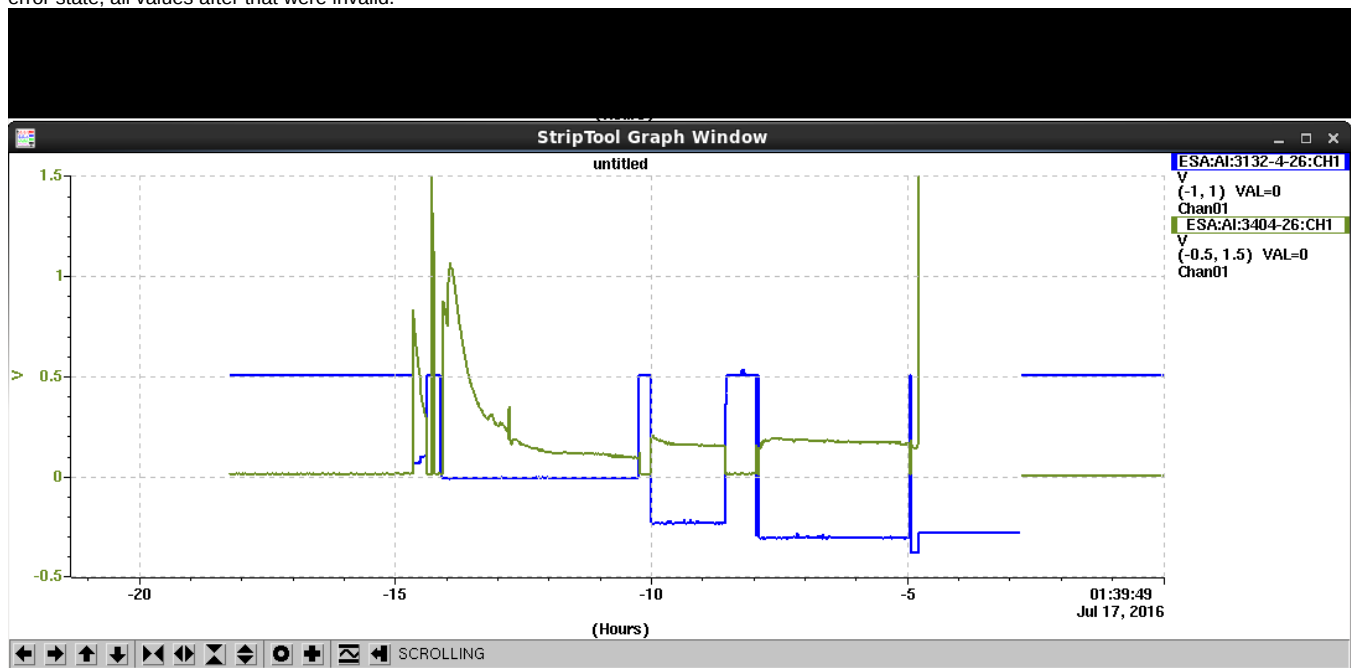
The newly installed Caladium ADC for the HV Vset and Imon: The green leakage current mon is roughly calibrated to the HV module's LEMO mon socket claimed of  $1\text{V}=1\text{mA}$ . The blue Vset calibration was a bit strange which showed  $-0.75\text{V}$  for  $-1\text{KV}$ . Glitch at  $-5\text{h}$  made Caladium stage control into permanent error state, all values after that were invalid.
