In certain circumstances excess noise has been observed at chip boundaries, where one sensor channel is read out by one chip and the neighbour is read out by another. This note is an attempt to explore a possible origin of this behaviour.

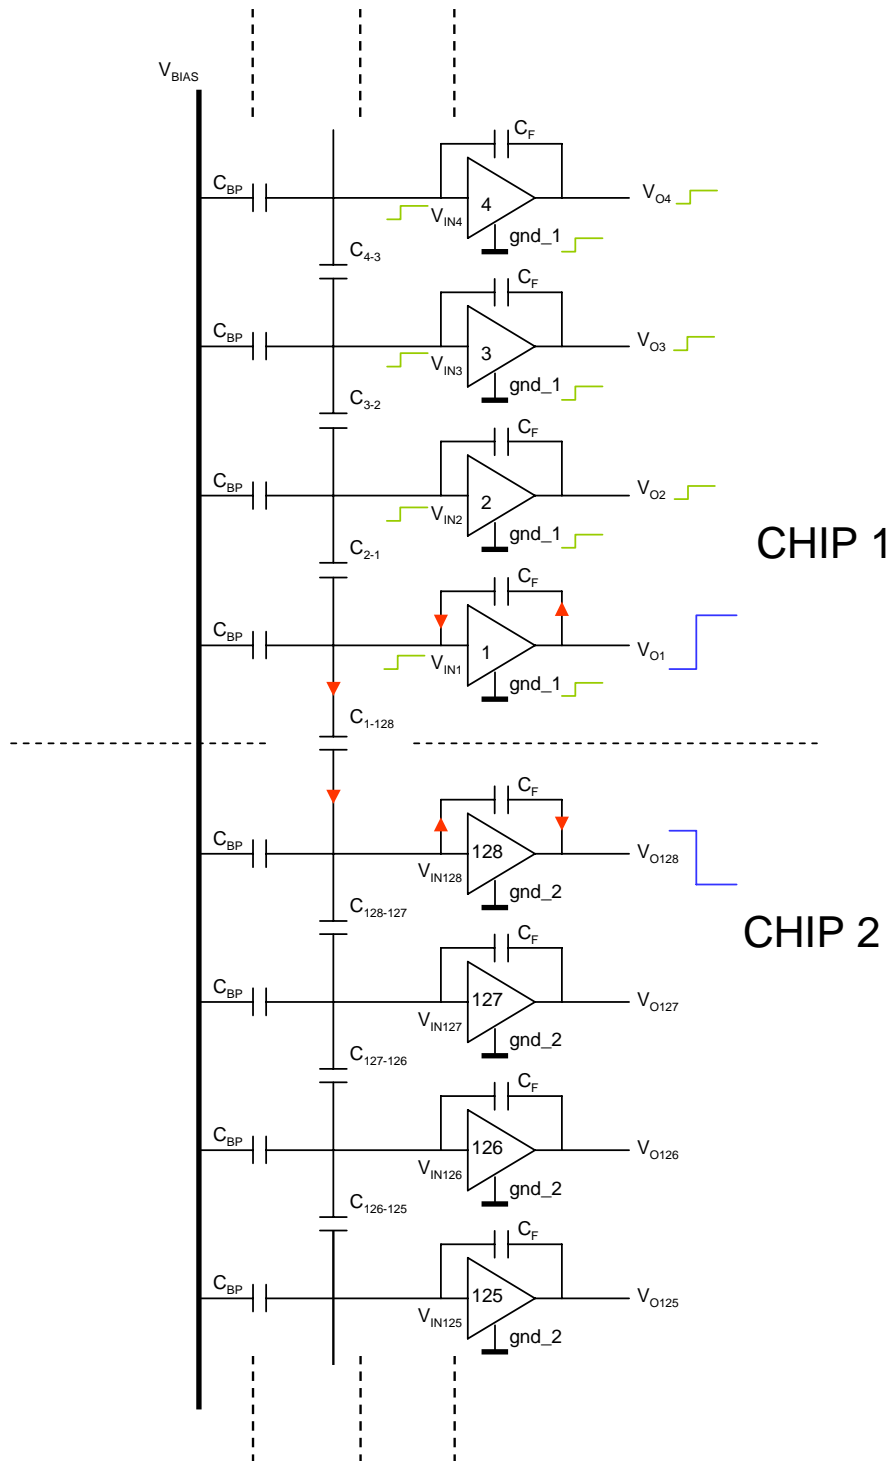
The schematic shows a simple model of the sensor capacitance network connected to the charge preamplifier inputs in the boundary region between two chips. Only four channels of each chip are shown; the bottom four (1 -4) of chip1, and the top four (125-128) of chip 2.

The capacitors C_{BP} represent the sensor strip capacitance to the bias line V_{BIAS} , but these play no part in the effect to be described here.

The preamplifiers of each chip are shown referenced to a supply reference on the chip (gnd_1 for chip 1, gnd_2 for chip 2). In an ideal system these two voltages would be identical, but it is interesting to explore what happens if they are not, because this can give rise to behaviour similar to that which has been observed. Although I have called the preamp references **gnd**, this is somewhat arbitrary. For example in the APV the input FET sources connect to V_{125} , so this would be the reference voltage.

For the edge channels the effect is different, but only if the preamplifier reference voltage of the neighbouring chip (gnd_2 for chip 2) does not see the same disturbance. If gnd_2 remains unchanged then the preamplifier input voltages V_{IN128} , V_{IN127} , V_{IN126} , ..., are also unchanged which leads to a transient current through the interstrip capacitance C_{1-128} coupling the edge channels between the two chips. This current is represented by the red arrows in the figure.

For the polarity of the voltage step on gnd_1 , the current will flow out of chip1/channel 1 into chip2/channel 128 and the outputs of the preamplifiers connected to those channel will show the step responses shown in blue; positive for chip 1, negative for chip 2. (Note that V_{O1} would also have a small contribution from the original disturbance on gnd_1 , which is present on all the other channels on chip 1.)

The quiescent voltages at the preamplifier inputs (sometimes called virtual grounds – but actually DC levels) are at a fixed DC offset with respect to the supply reference level. For example if gnd_1 were to change by a voltage ΔV , then all the preamplifier input and output quiescent voltages would change by the same amount. The green waveforms in the schematic show the effect of a step change in gnd_1 on the input and outputs of the preamplifiers in chip 1, which will all show the same step change. For all the channels, with the exception of the edge channels, this is a common mode effect which can be removed.

This effect could only happen for edge channels. For channels within a chip the input voltages either side of the interstrip capacitance change by the same amount (in response to a change in the preamp reference voltage), so there is no current flow.

A typical value for the interstrip capacitance might be ~ 15 pF. A step voltage disturbance of just 1mV on gnd_1 with respect to gnd_2 would cause a positive charge injection of 15 fC into channel 128 of chip 2, and a correlated negative charge injection of -15 fC into channel 1 of chip 1. These are huge signals, but on the other hand gnd_1 and gnd_2 are connected together on the hybrid by a very low impedance ($\sim m\Omega$?) so a difference of as much as 1 mV is unlikely.
